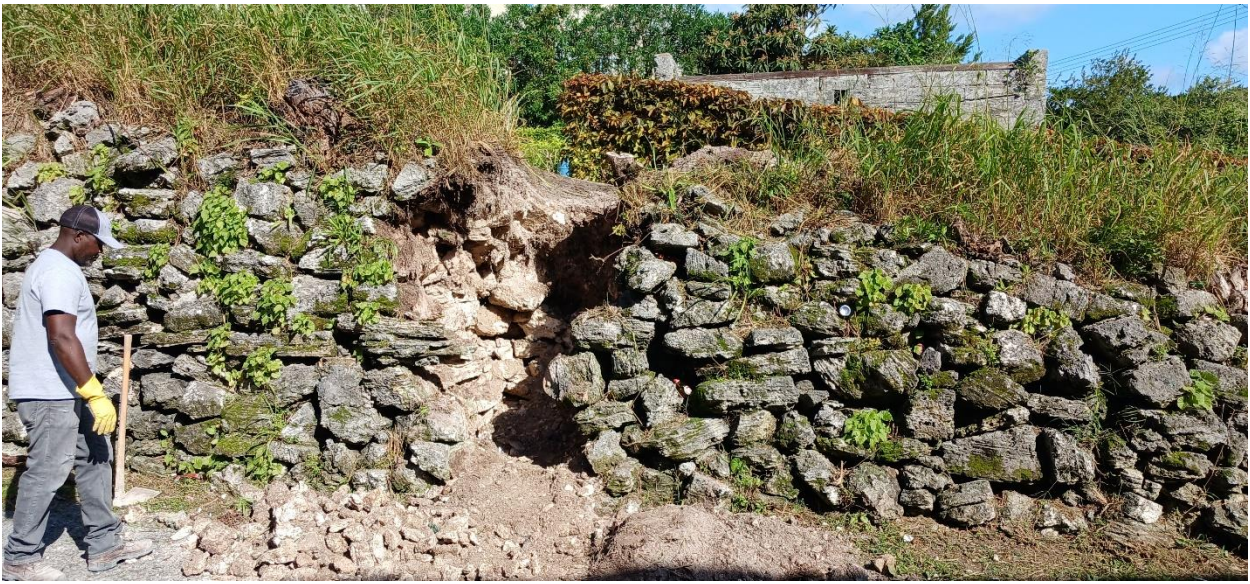
*Figure 1 - Intrusive investigation into dry-stone wall*

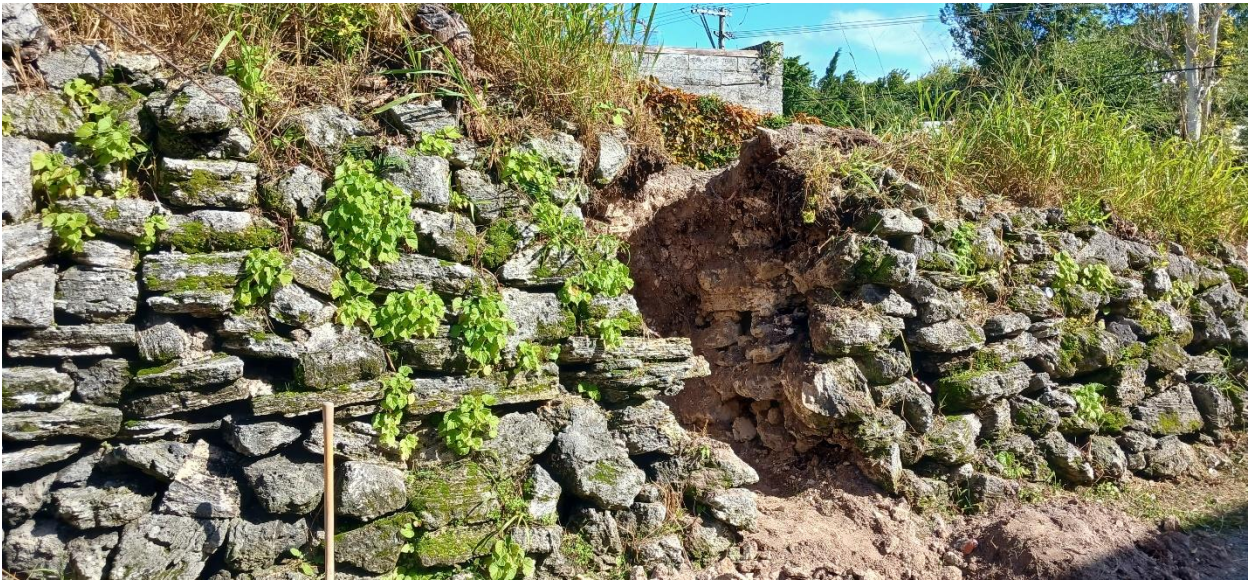
*Figure 2 - Further view of investigation. No sound rock was found, only fill material and dry stack.*

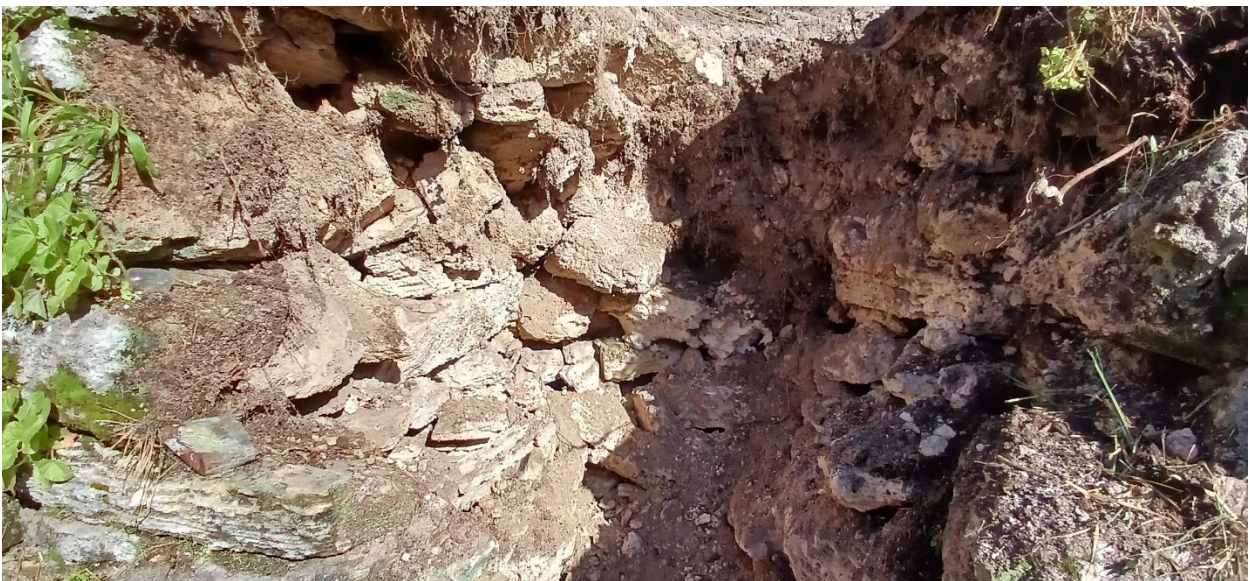
*Figure 3 - Close up view of investigation. Only fill material found.*
