Visual Structural Inspection Report

Watford Bridge

Submission Date: 5th March 2024

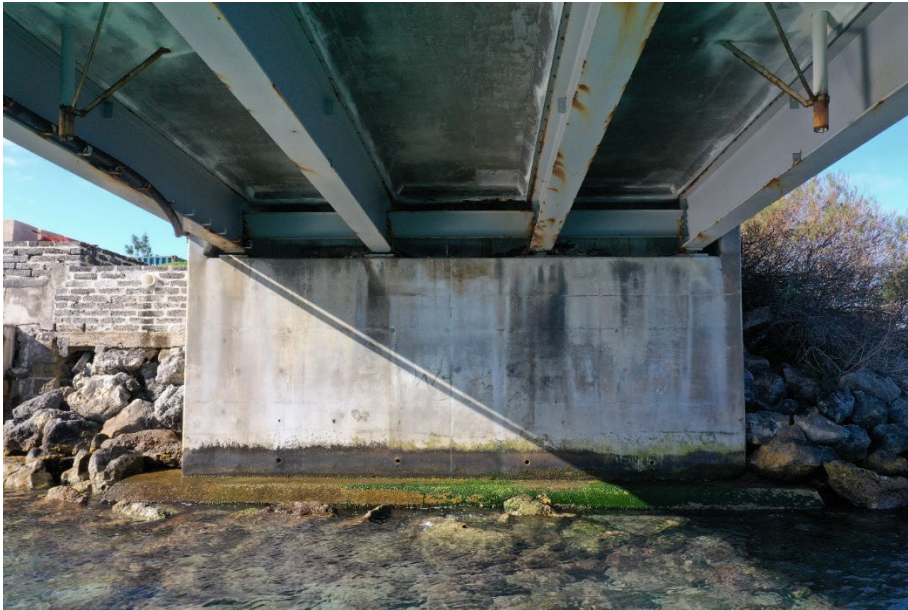
1. Abutments A1 and A2 appear to be in good condition. No significant signs of structural distress, such as substantial cracking, spalling or displacements were observed on the visible surfaces of the inspected elements. The concrete surfaces exhibited minimal deterioration, with no apparent indications of significant corrosion or erosion.

Photograph 1 – Abutment A1 – Elevation.

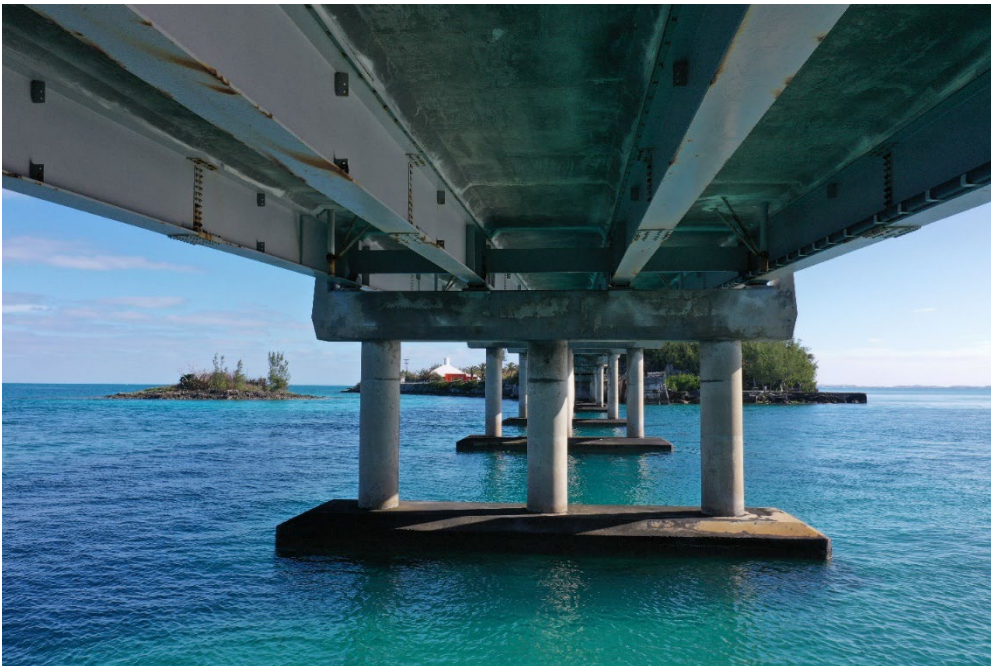
Photograph 2 – Span 1 main girders.

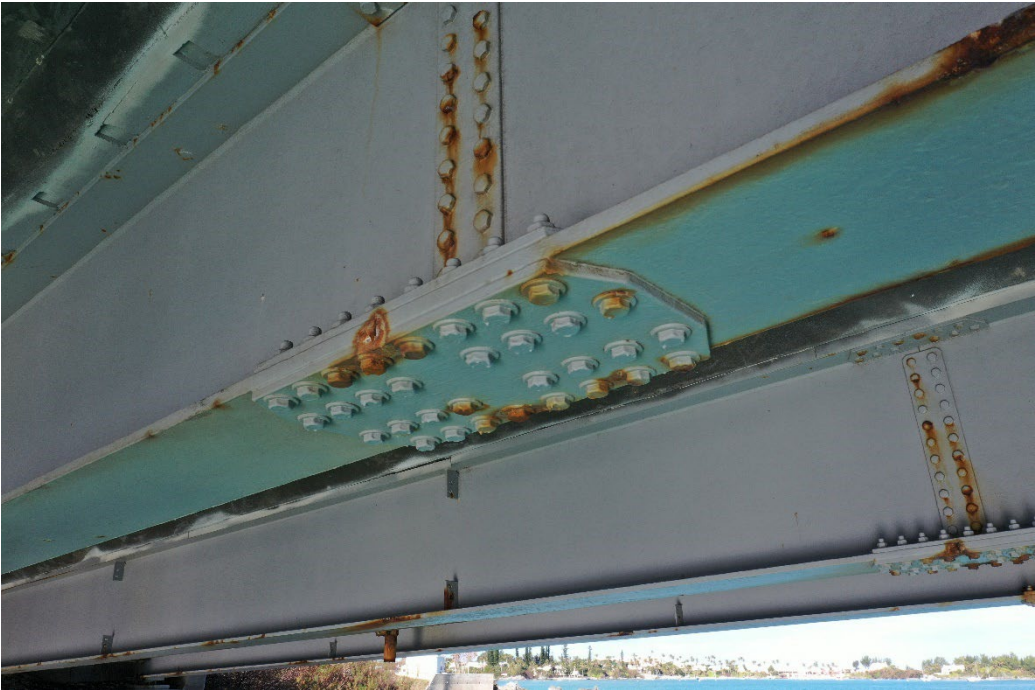
Photograph 3 – Span 1 Plate girder splice connection.

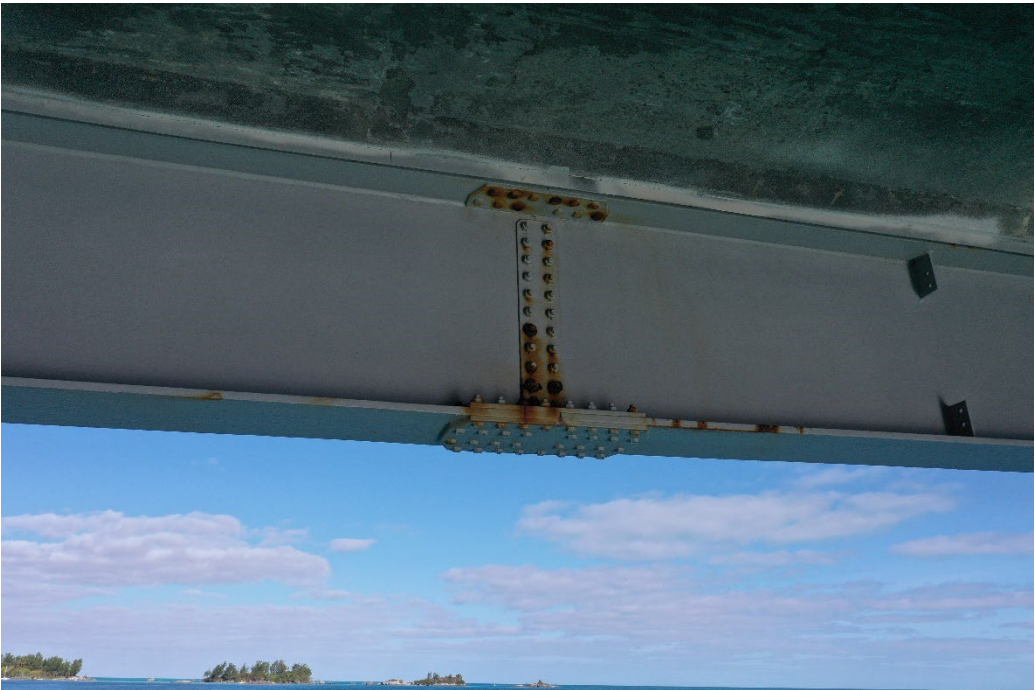
Photograph 4 – Span 1 Plate girder splice connection (1).

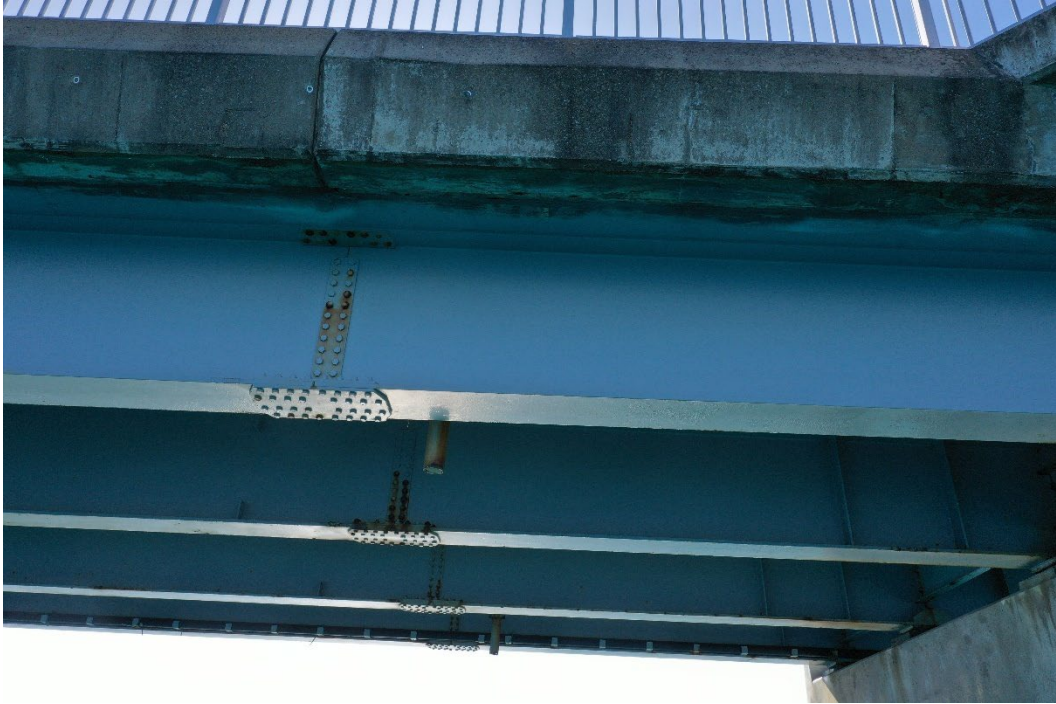
Photograph 5 – Span 2 plate girder splice connection.

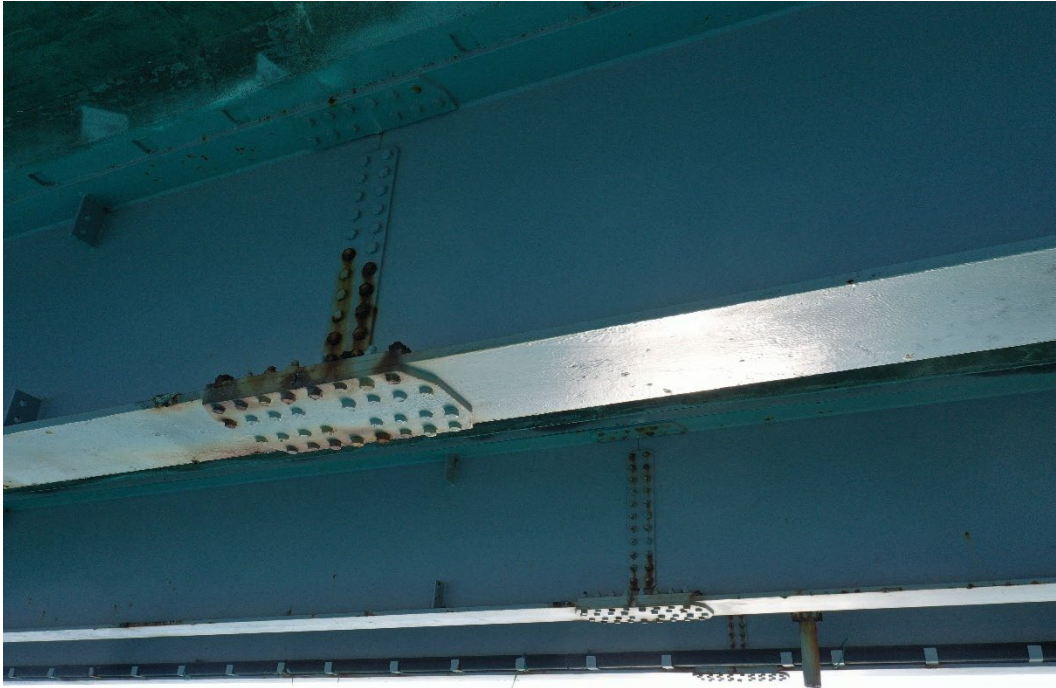
Photograph 6 – Span 2 plate girder splice connection (1).

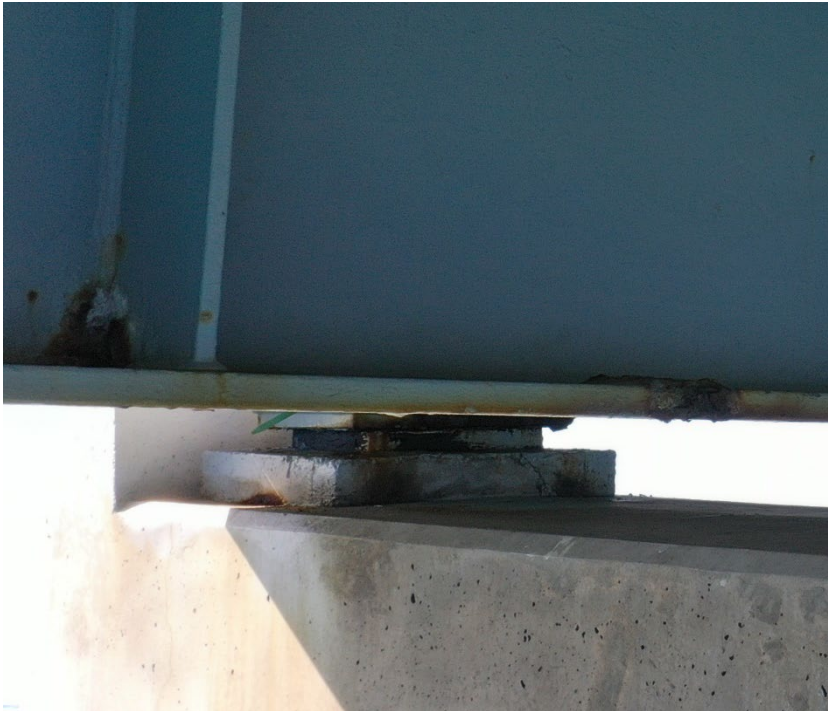
2. The bridge bearings were generally observed to be in fair condition. However, in quite a few instances the steel plate girders above the bearings appeared to have excessive local corrosion and/or the supporting concrete bearing plinths exhibited signs of distress, including crushing or cracking.
 - a. Bearings B3, B9, B10, B12, B13, B14, B15, B16 and B31 show visible signs of concrete plinth cracking/crushing and/or excessive localized corrosion of the supported steel plate girder above, as shown in Appendix A.
 - b. It is recommended that the affected plate girder steel be cleaned and coated as per the coating specification.
 - c. It is recommended that the concrete bearing plinths be repaired or replaced as required.

Photograph 7 – Bearing B9 showing vertical and diagonal cracking.

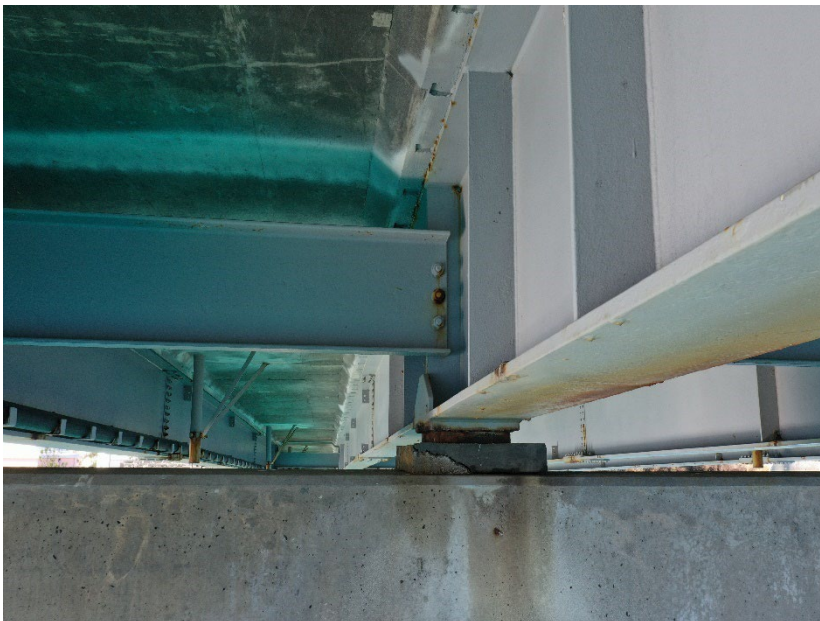
Photograph 8 – Bearing B10 showing a diagonal crack.

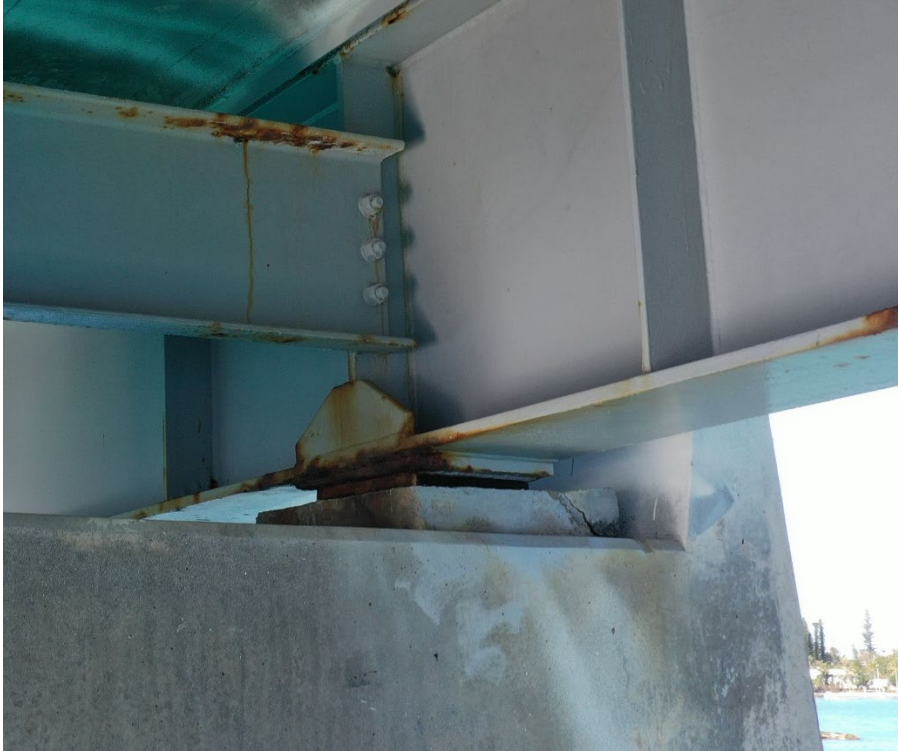
Photograph 9 – Bearing B12 showing local cracking on the edge of concrete plinth.

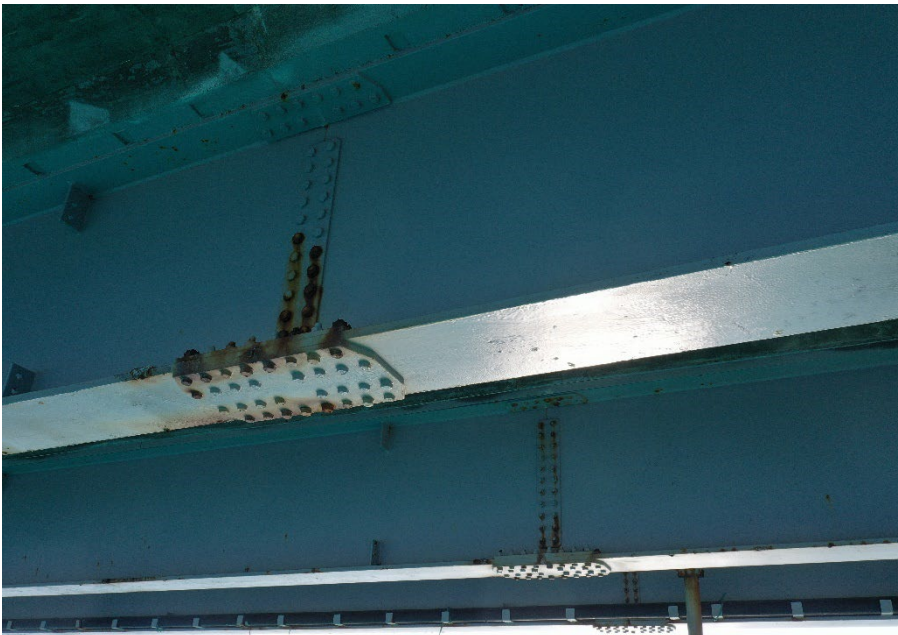
Photograph 10 – Span 3 splice connection corrosion.

1. The overall condition of the plate girders appear to be in fair to good condition. However, it is recommended that approximately 20% of the plate girder flanges undergo recoating to prevent further corrosion and preserve their structural integrity. The recoating process should be carried out in accordance with the approved coating specification.
2. All splice plate connections should be recoated and prior to this undergo a close distance touching inspection to further assess the bolt condition. Any deteriorated coating should be removed, and the connections recoated in accordance with the coating specification. Additionally, bolts showing signs of corrosion or excessive wear should be replaced as necessary to ensure the integrity of the connections.

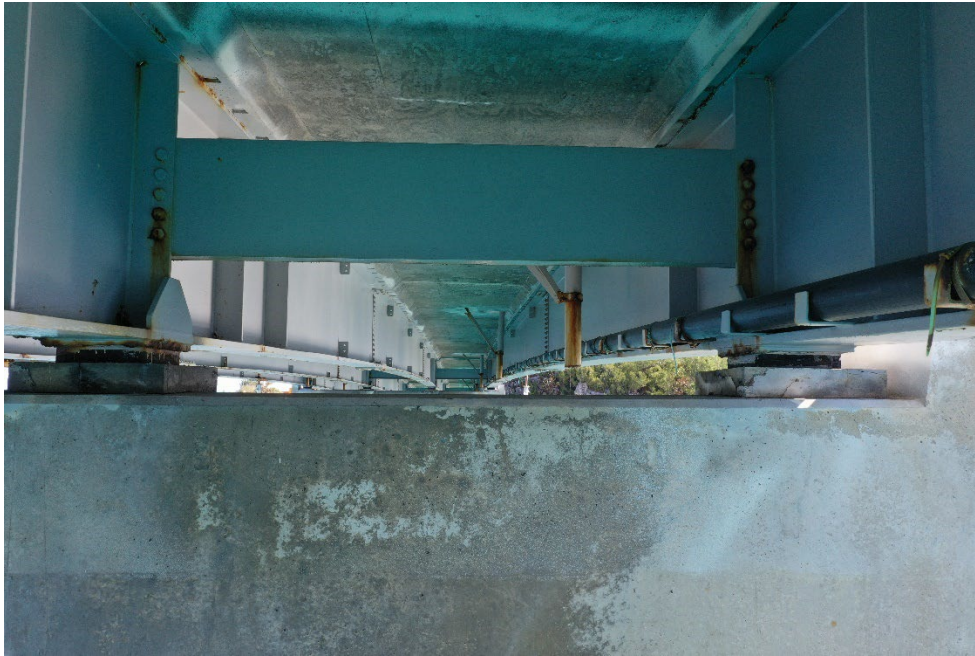
Photograph 11 – Bearings 13 and 14 showing cracking of the concrete plinths.

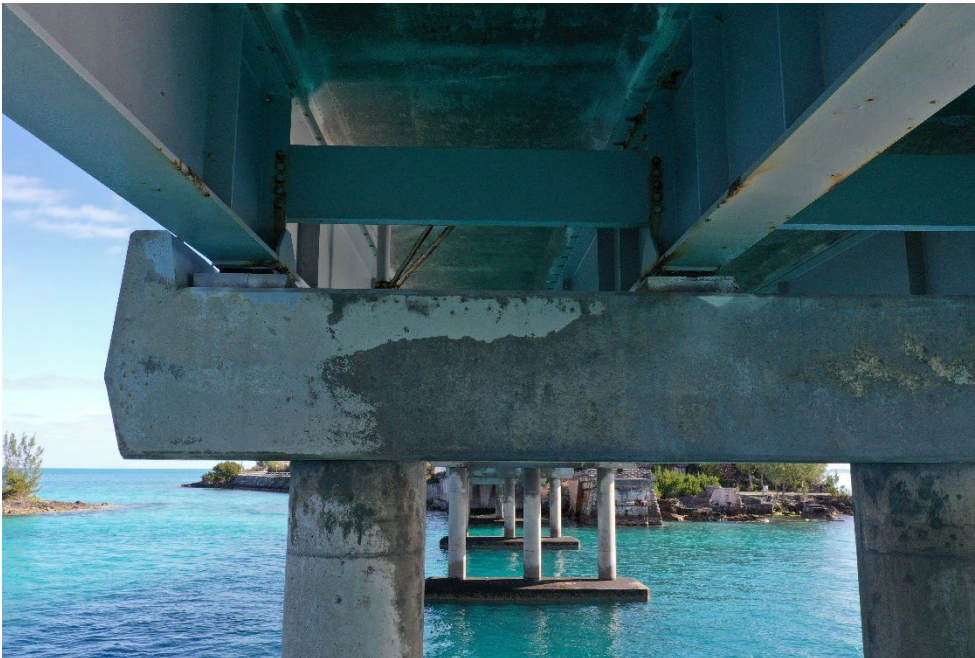
Photograph 12 – Bearings 15 and 16 showing cracking of the concrete plinths

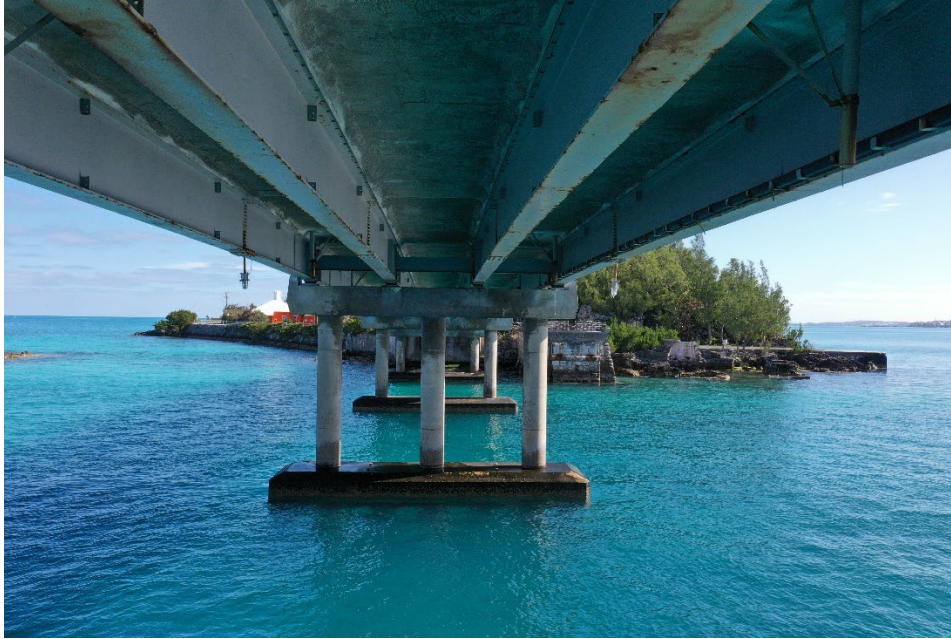
Photograph 13 – Span 4 Main Girders.

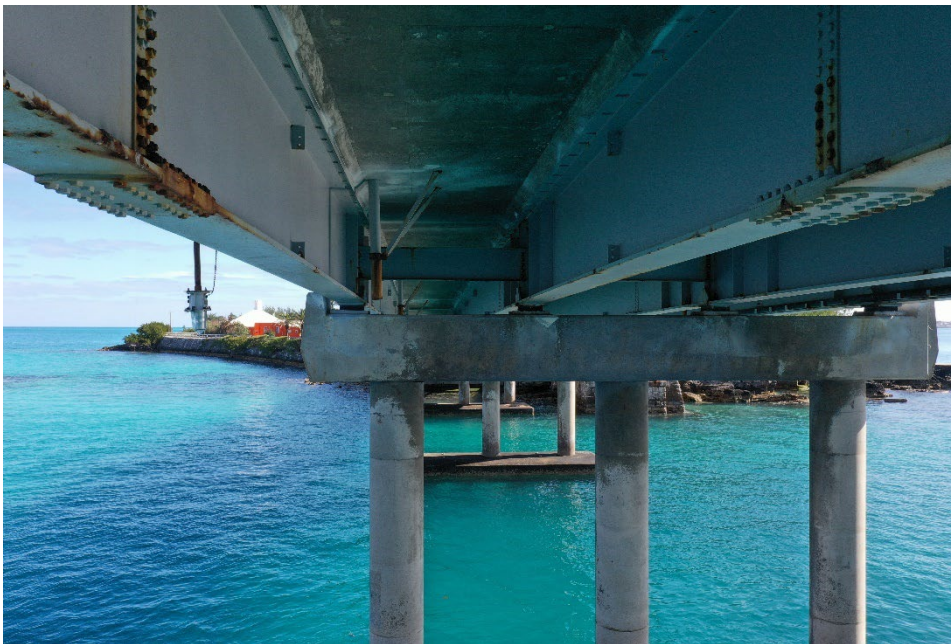
Photograph 14 – Span 4 Main Girder Splice Connections

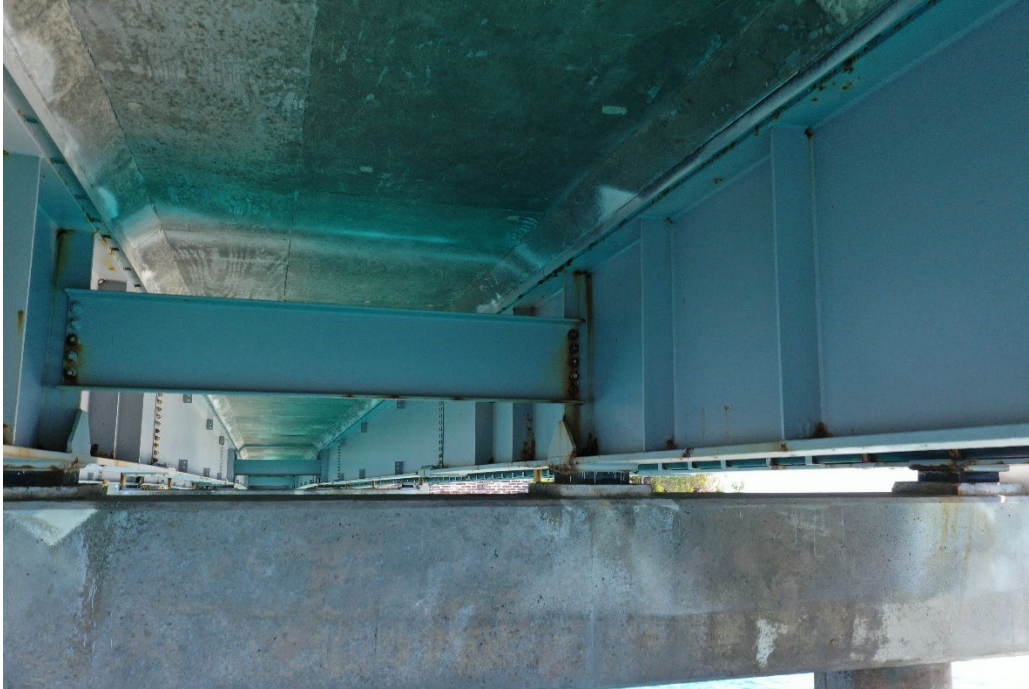
Photograph 15 – Span 5 Main girders.

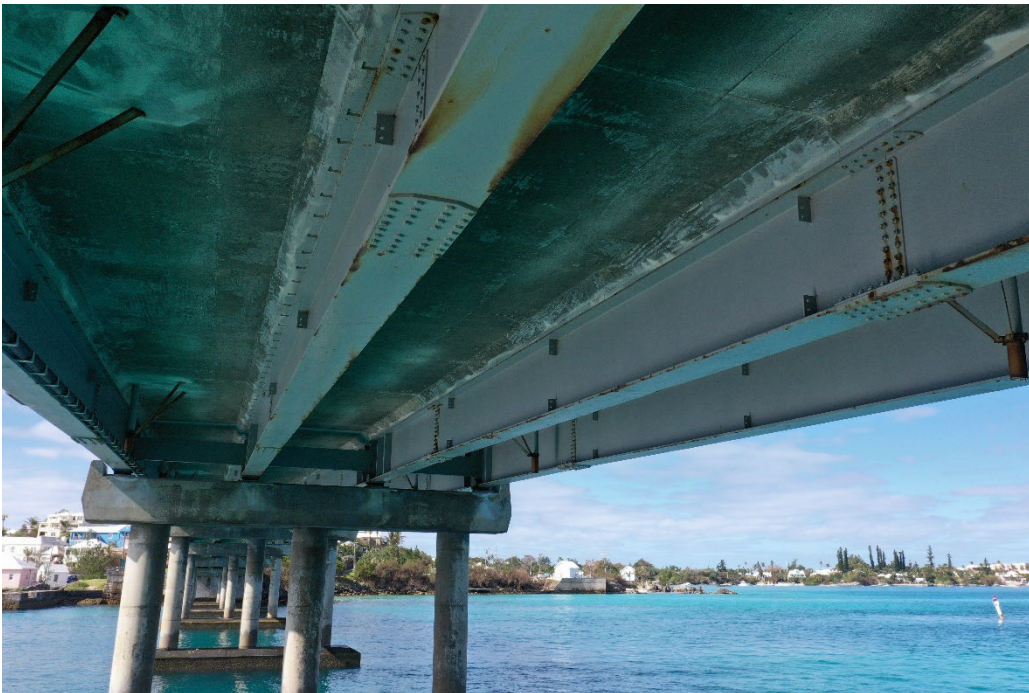
Photograph 16 – Span 6 Main girders and splice connections.

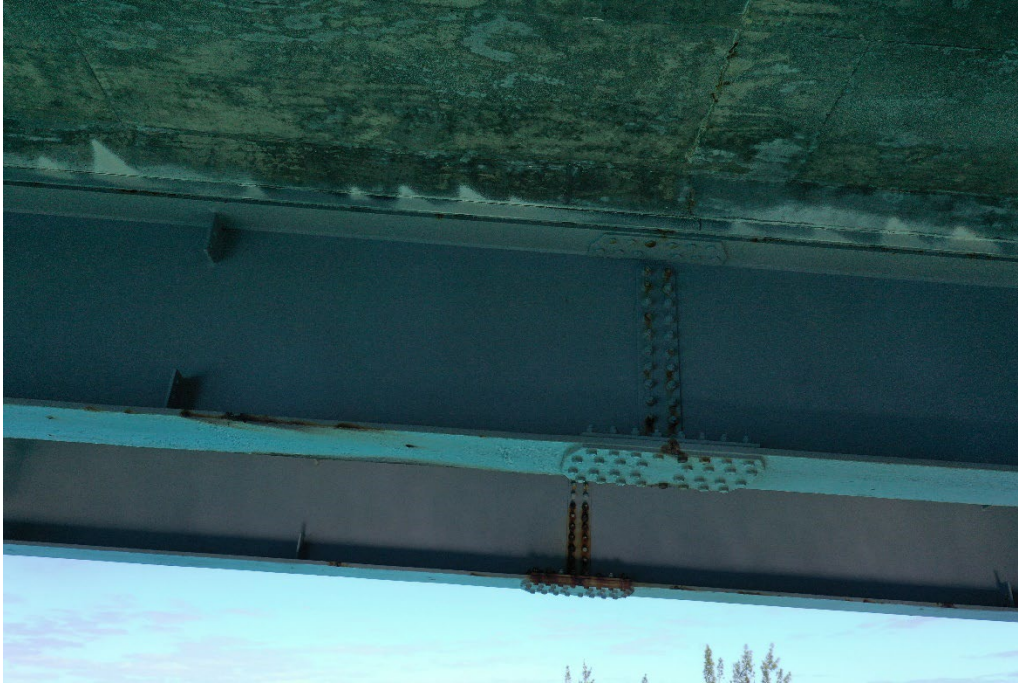
Photograph 17 – Span 7 Main girders and splice connections.

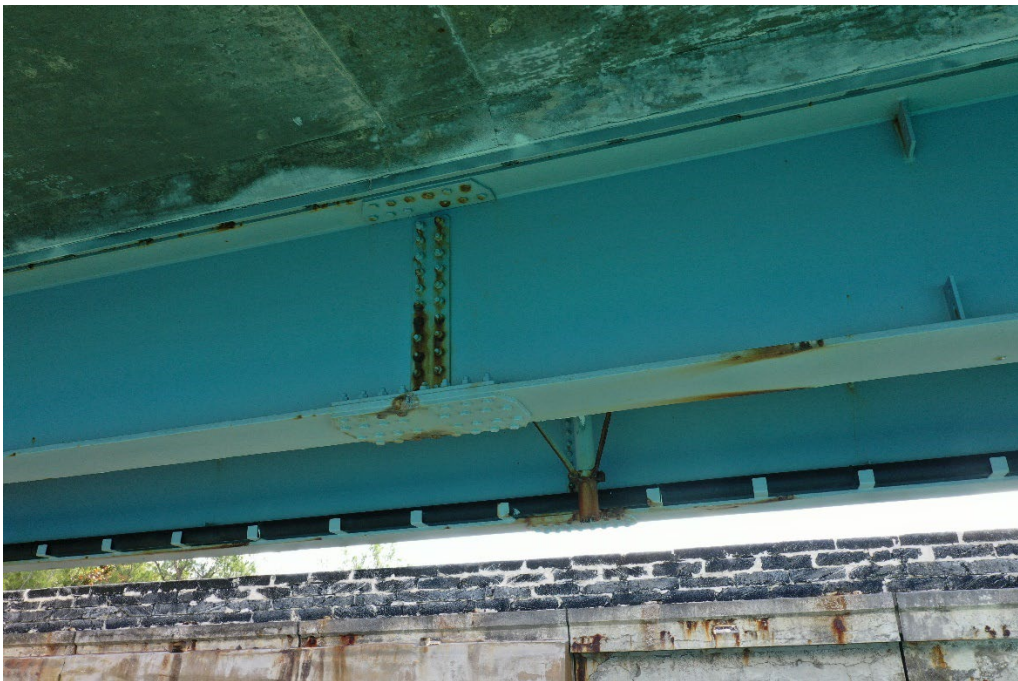
Photograph 18 – Span 7 Main girders and splice connections(1).

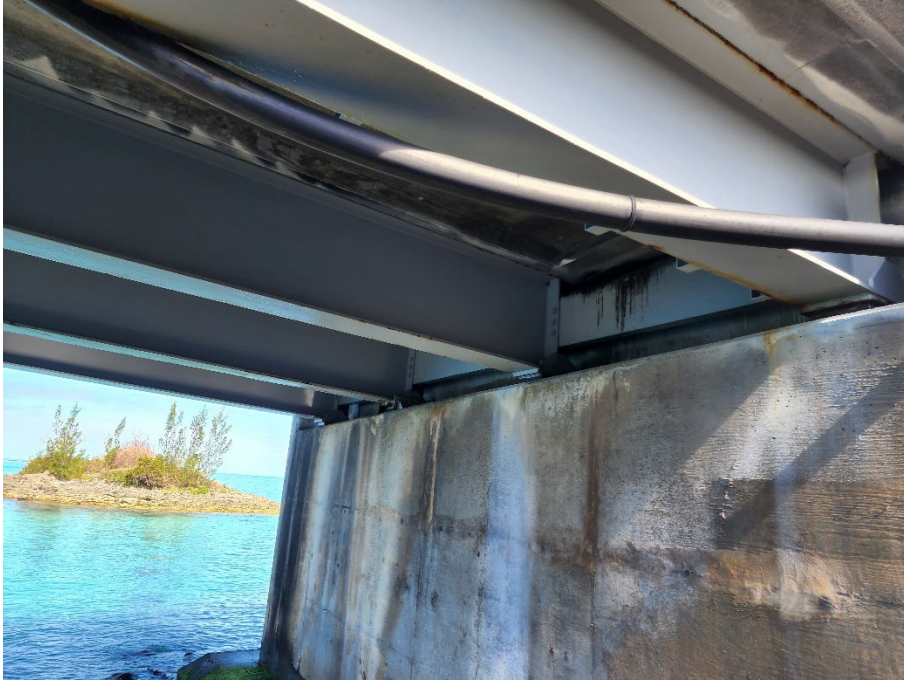
Photograph 19 – Abutment A2.

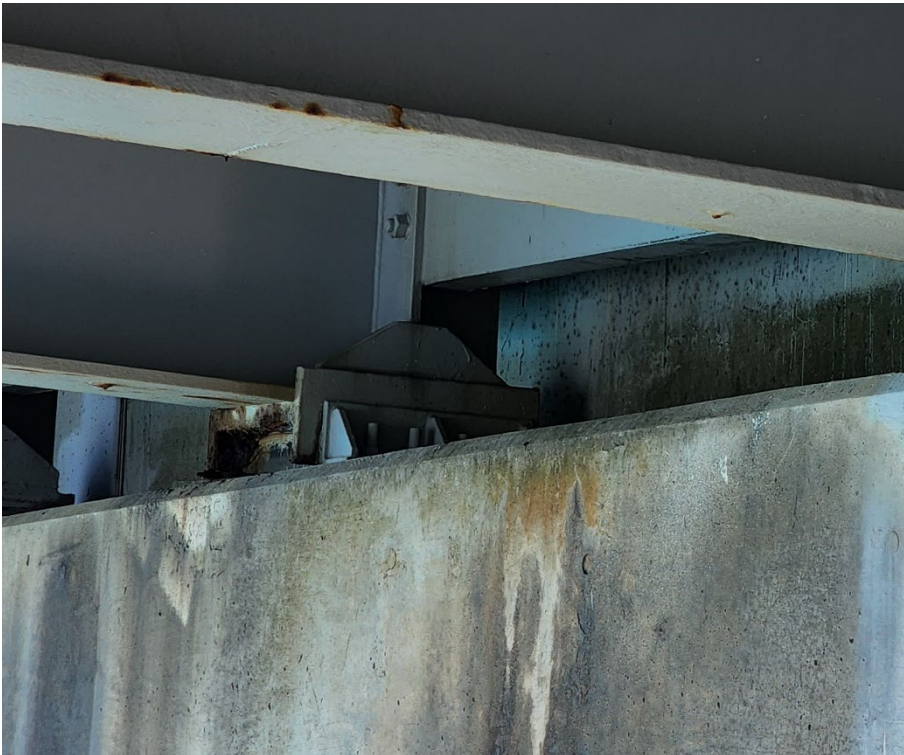
Photograph 20 – Bearing B31 showing corrosion of steel plate girder above.
