<b>Site Name:</b>	Prospect Tower
<b>Structure Type:</b>	Guyed Tower
<b>Structure Height:</b>	220'
<b>Make:</b>	Rohn
<b>Model:</b>	80
<b>Tower Owner:</b>	Government of Bermuda
<b>Address:</b>	Fort Hill Road
<b>Parish:</b>	Devonshire
<b>Latitude:</b>	32.299186
<b>Longitude:</b>	-64.765877
<b>Date of Visit:</b>	6/3/2019
<b>Employees on Site:</b>	Angie Shyrigh
	Ben Shyrigh
	Brian Heiney

**Proventus Structural Services, LLC**

To fulfill the inspection requirements set forth in the TIA/EIA222-G, Annex J.1 standard for Maintenance and Condition Assessment of communication structures.

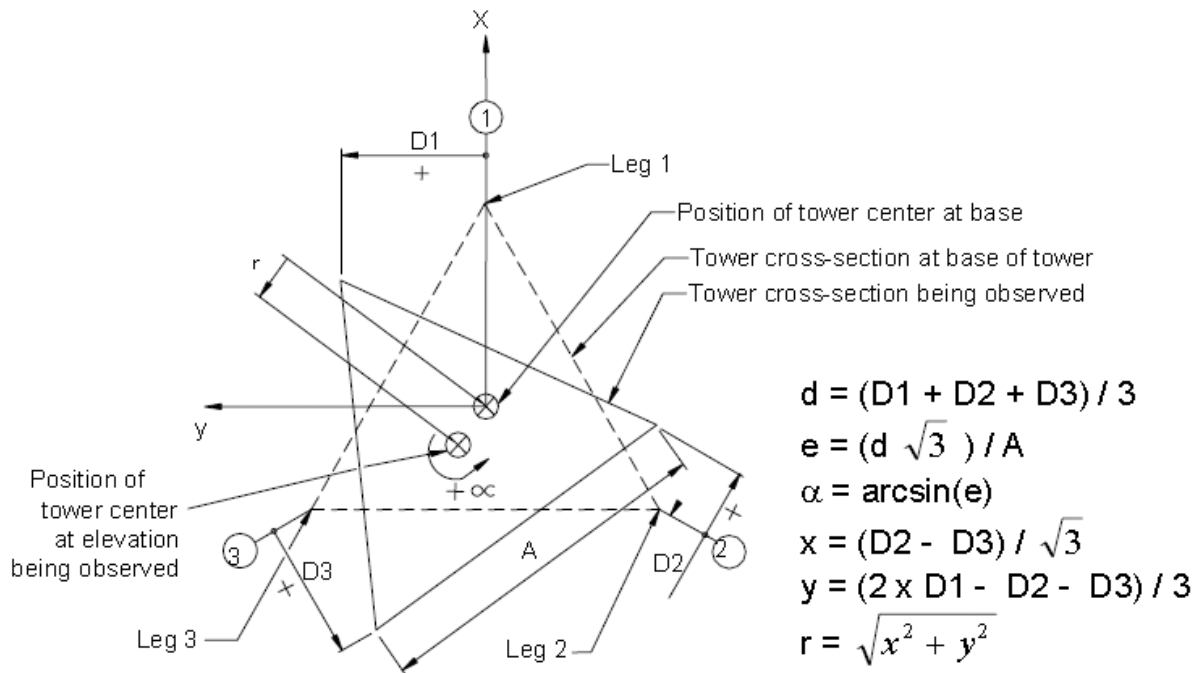
The tower twist and plumb are within acceptable limits.

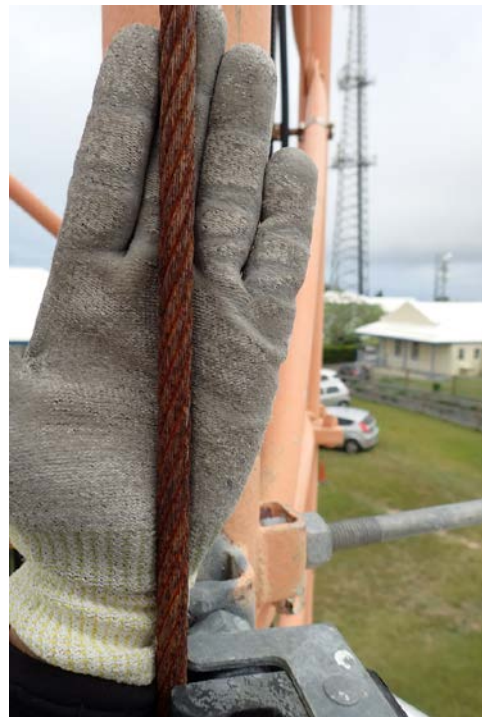
Elevation	Location	Description	Recommendation	Priority
Throughout height	C Leg	Category 3 rust is present on the safety cable.	It is recommended the safety cable system be replaced and that the safety cable kit be installed per manufacturer's specifications.	To be scheduled within 12 months

Safety cable condition  
File 048

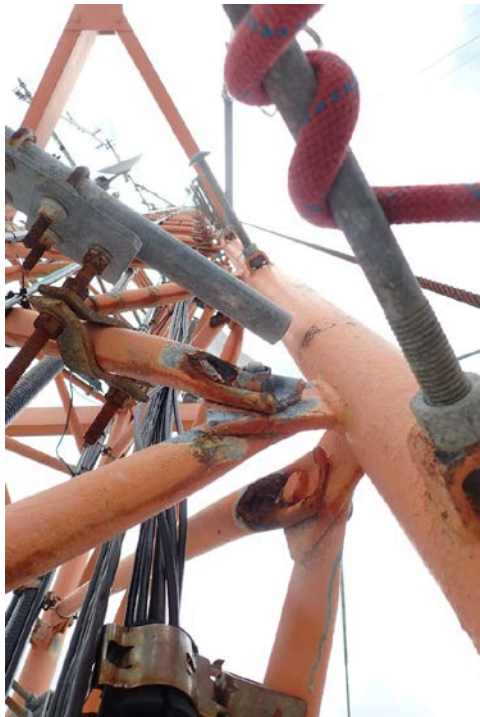
- Scaling rust is present at the C Leg weld to the base plate. This region of rust has advanced rapidly since the 2017 inspection
- Antenna #9 is a 4’ microwave dish mounted to a 4’ long antenna mount. It has a stiff arm which is connected to a diagonal member. This member is rusted though at its lower connection with only an estimated 50% of original material remaining.

Antenna #10 stiff arm connection to damaged diagonal  
File 077

Elevation	Location	Description	Recommendation	Priority
78'	AB face	Dead feedlines (loading item #15) were observed to be installed.	It is recommended out of service or otherwise abandoned equipment be completely removed from the structure in order to reduce the resources required to maintain safe connection to the structure as well as to maintain accurate loading records.	To be scheduled
Varies	Varies	The stiff-arm associated with each antenna # 8, #9, #10, #11 is connected to a tower bracing member.	In order to prevent damage to the already structurally compromised bracing members it is recommended the stiff-arm connection be relocated to a tower leg.	To be scheduled

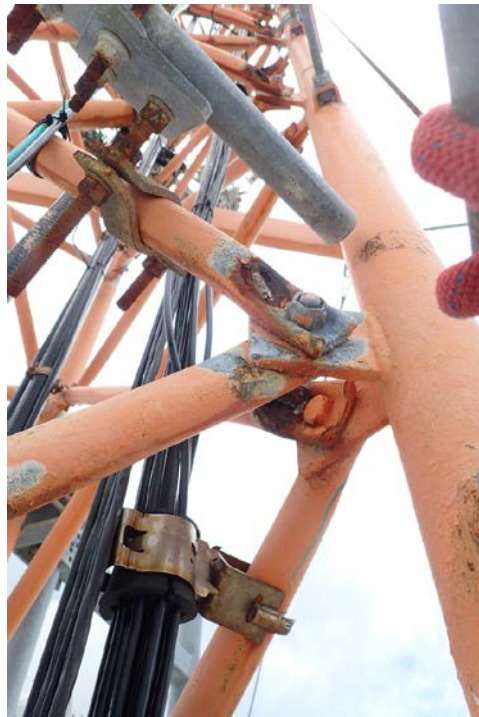
Antenna #10 stiff arm connection to damaged diagonal  
File 078

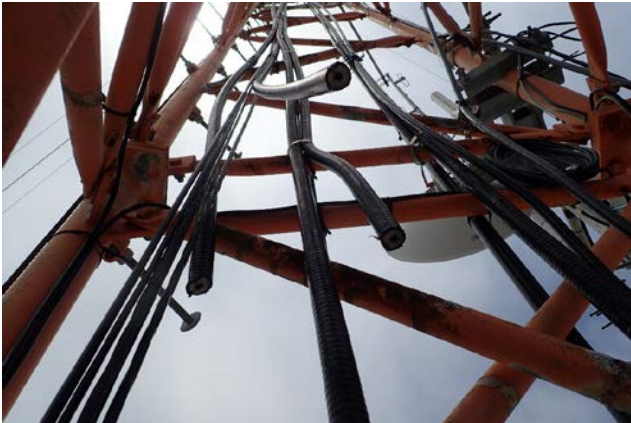
Dead feedlines  
File 103
