<b>Site Name:</b>	Prospect Tower
<b>Structure Type:</b>	Guyed Tower
<b>Structure Height:</b>	220'
<b>Make:</b>	Rohn
<b>Model:</b>	80
<b>Tower Owner:</b>	Government of Bermuda
<b>Address:</b>	Fort Hill Road
<b>Parish:</b>	Devonshire
<b>Latitude:</b>	32.299186
<b>Longitude:</b>	-64.765877
<b>Date of Visit:</b>	6/3/2019
<b>Employees on Site:</b>	Angie Shyrigh
	Ben Shyrigh
	Brian Heiney

**Proventus Structural Services, LLC**

To fulfill the inspection requirements set forth in the TIA/EIA222-G, Annex J.1 standard for Maintenance and Condition Assessment of communication structures.

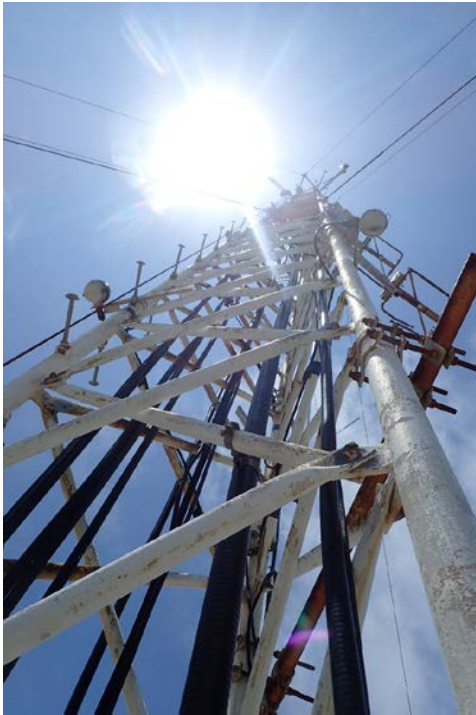
Tower surface condition  
File 113

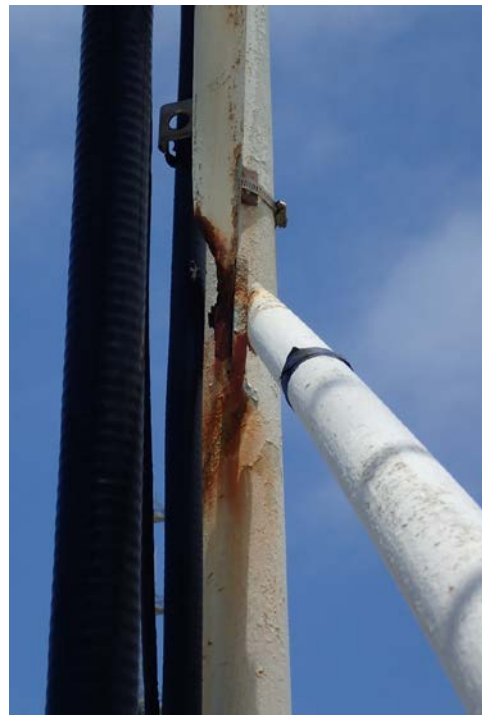
Tower surface condition  
File 124

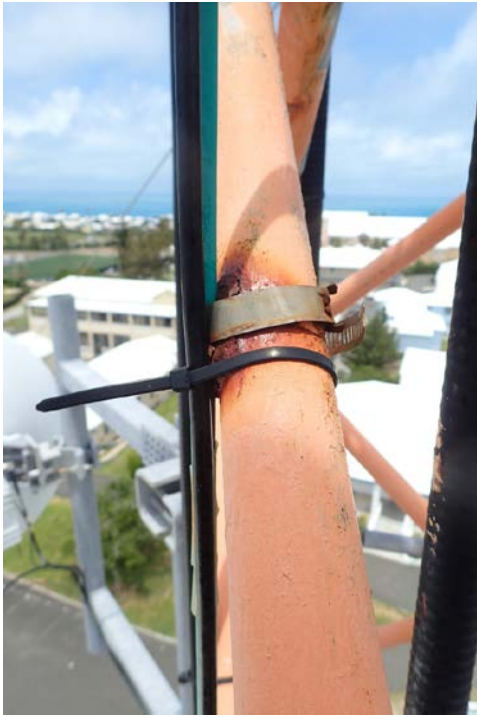
Tower surface condition  
File 129
