GOVERNMENT OF BERMUDA

Ref: 44-02-115-C Swing Bridge Deck Repairs 2023

PROJECT NAME:
SWING BRIDGE
TEMPORARY
REPAIRS 2023

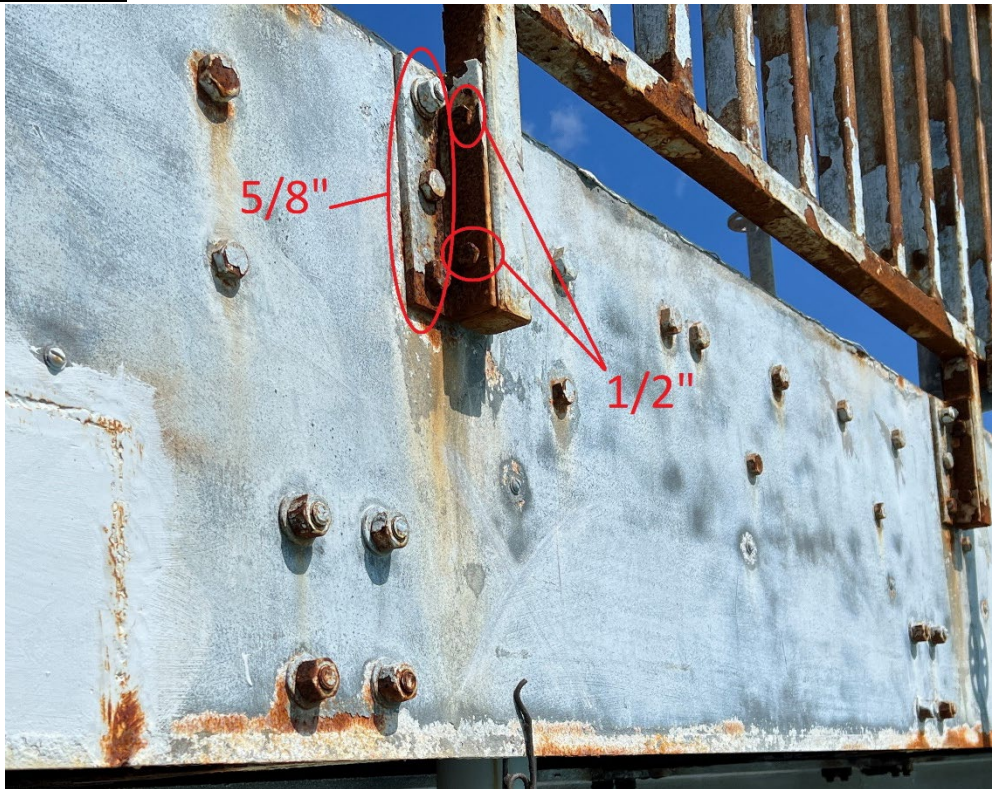
Photograph 1 – Bolt clarification

1. Q) Please advise the size of the bolts that hold the handrail to the decking edge plate as their not shown or called out in the drawings. These will probably have to be replaced with new as we think that many will have to be cut off, so we want to allow for a certain percentage of replacement bolts.

A) After receiving this question we measured the bolts on site and checked the record drawings. The handrail bolts are two different sizes. Bolts connecting the angle bracket to the handrail are 1/2", while the bolts connecting the angle bracket to the decking edge plate are 5/8". The relevant drawing S301 has been updated to reflect this information, and a photograph is included for additional clarity.

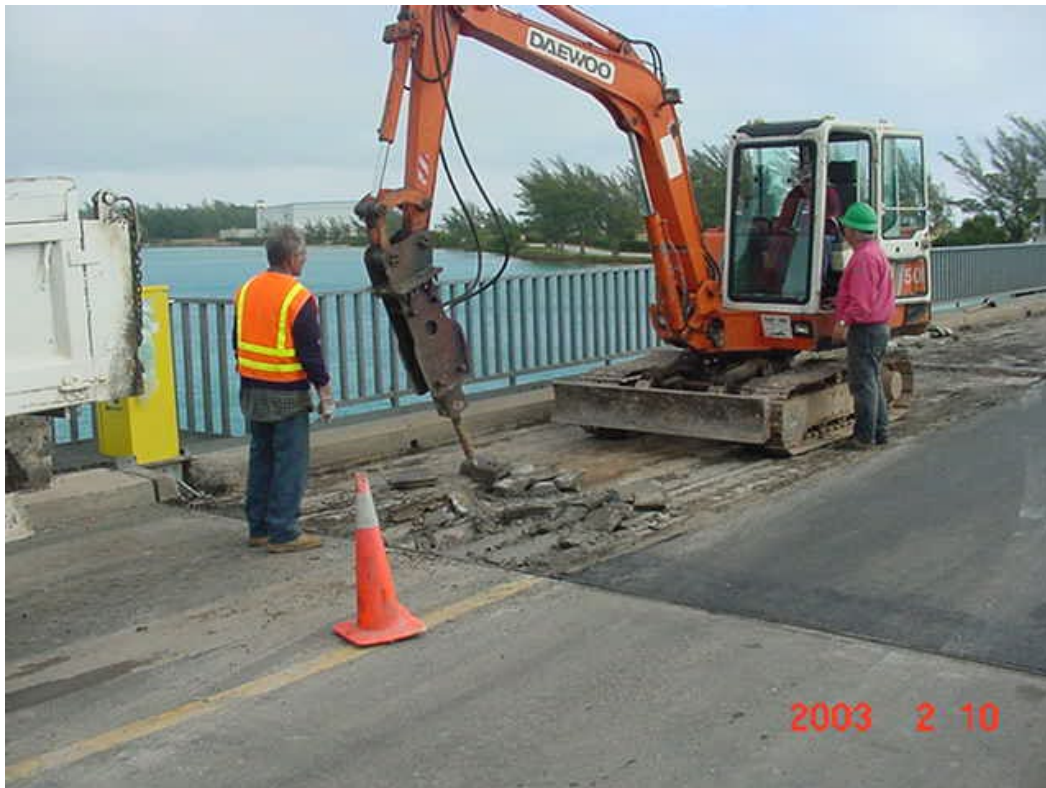
Photograph 2 – Excavator removing concrete from troughs

A) The decking was repaired in 2002/3, and this work included new concrete. The concrete removal work was done with a small excavator and skid loader. Engineer at the time reported that the concrete came out easily, in large chunks along the trough. Refer to photographs. The concrete was reinstated with a 4500psi mix supplied by Biermans (actual strength achieved often exceeds design value). Our test digs showed that the top surface of the troughing is in good condition, and we expect that the concrete-steel bond will be as described during the 2002/3 works.

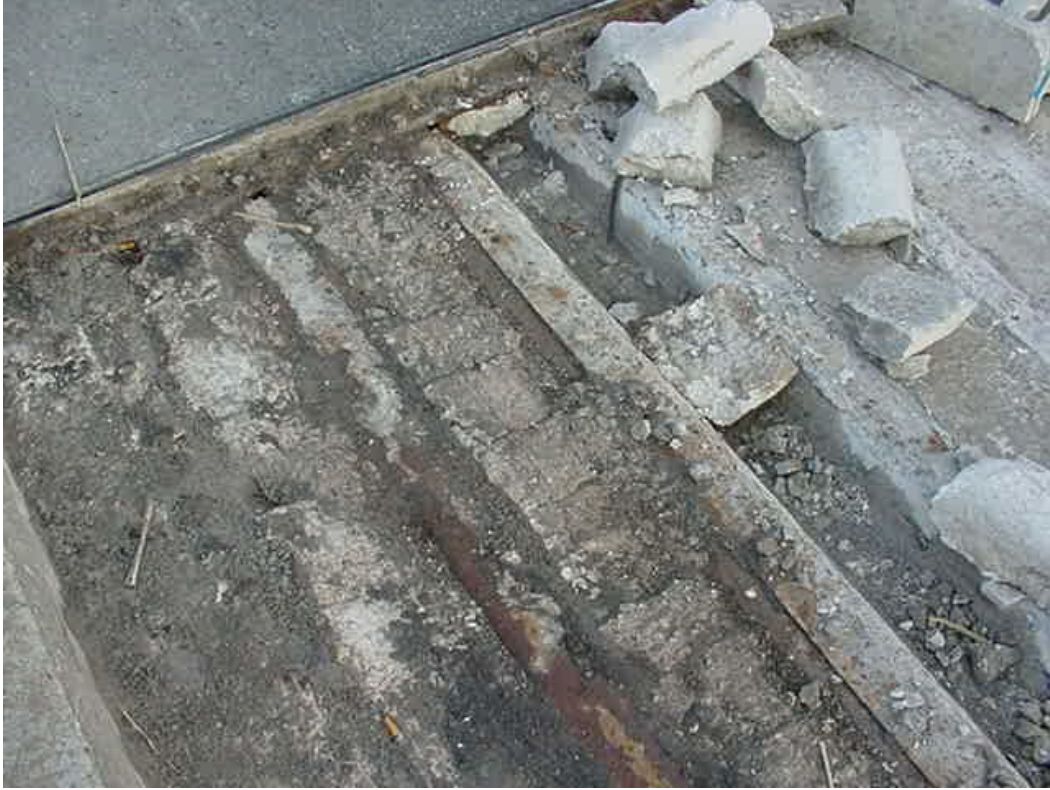
Photograph 3 – Chunks of concrete during removal, approx. 8" long

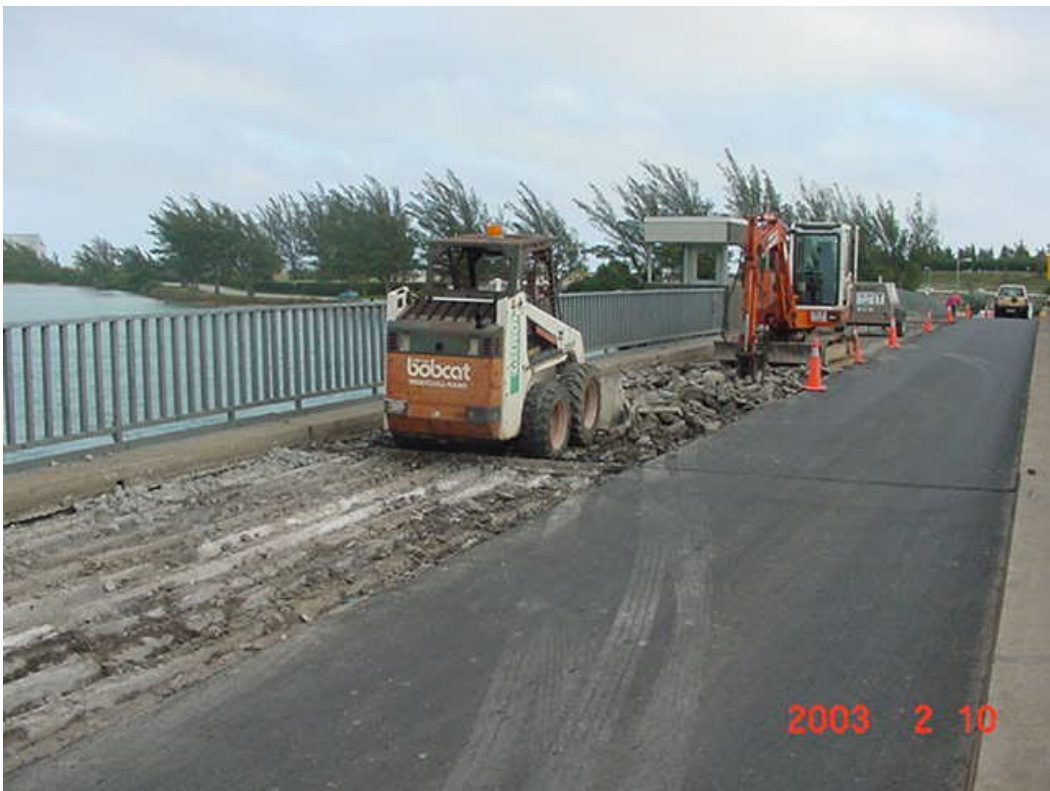
Photograph 4 – Concrete removal

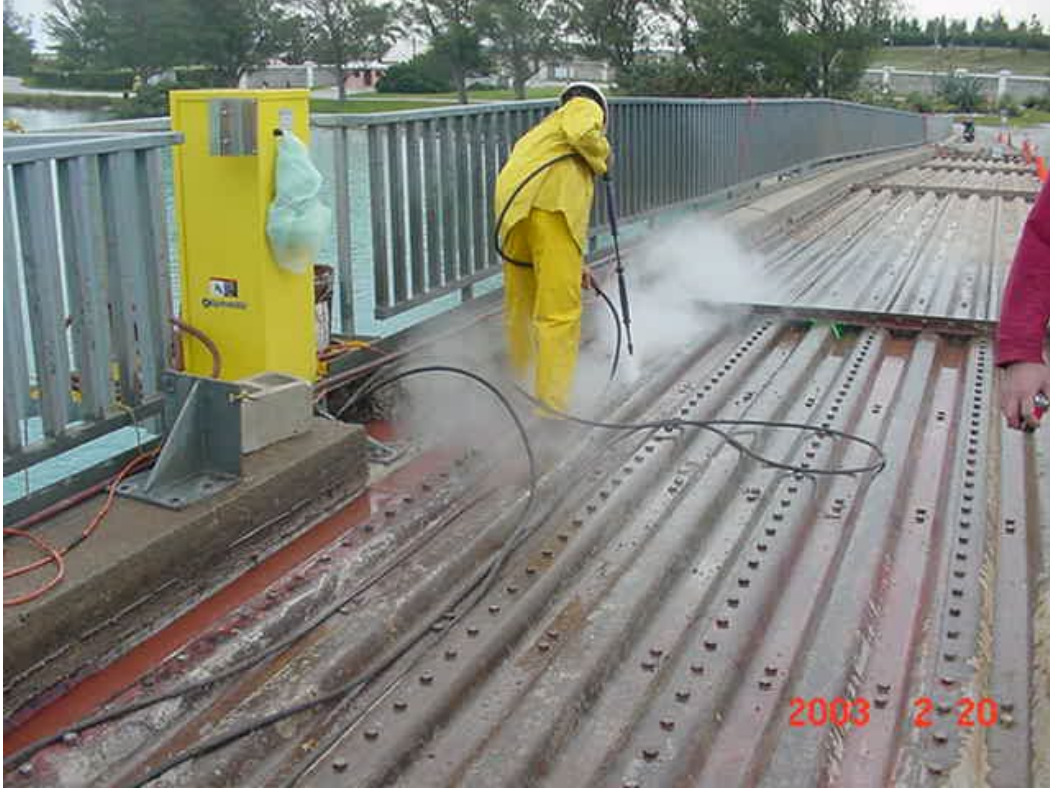
Photograph 5 – Deck cleaning

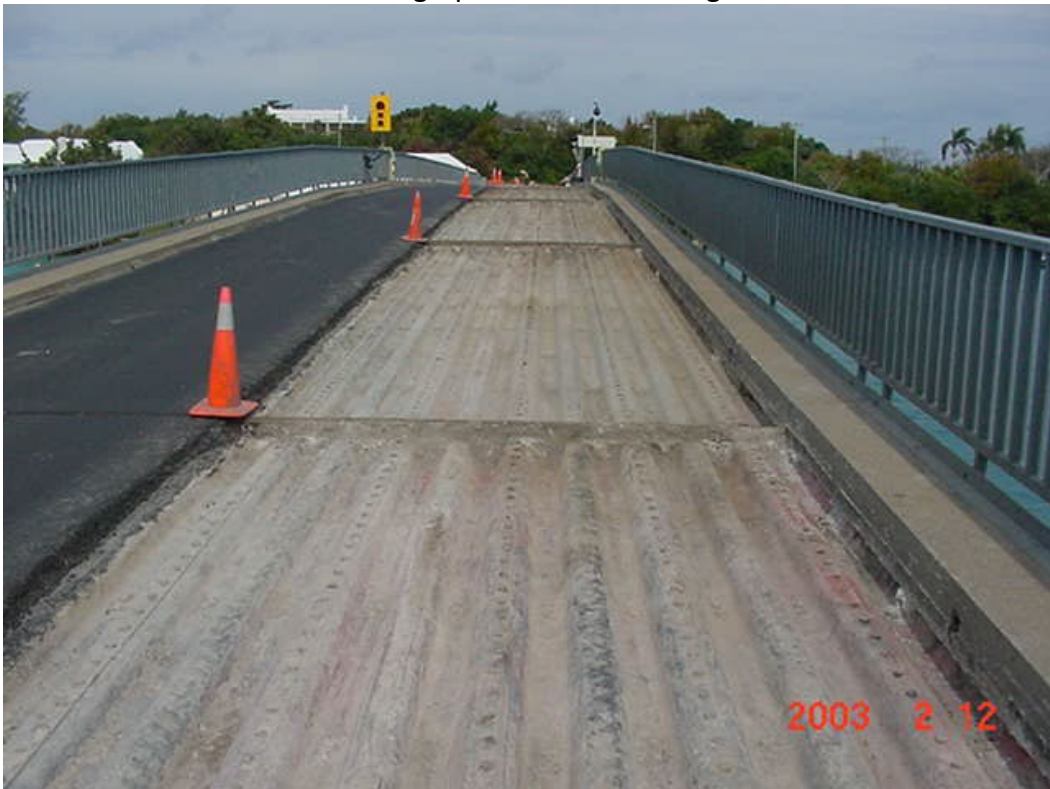
Photograph 6 – Bare troughing

While the top surface of the steel troughing is believed to be in good condition, the soffit is extensively corroded, particularly in the areas of the work. Contractors should take care when selecting equipment and method of demolition

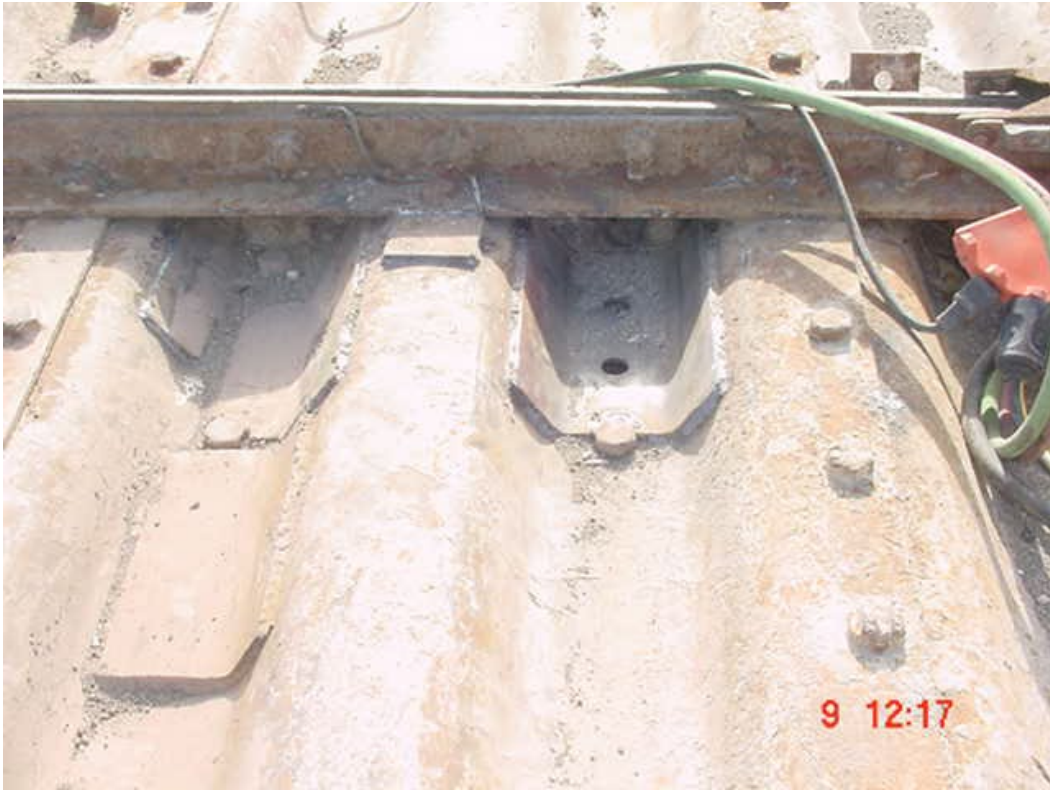
Photograph 7 – Span end plates

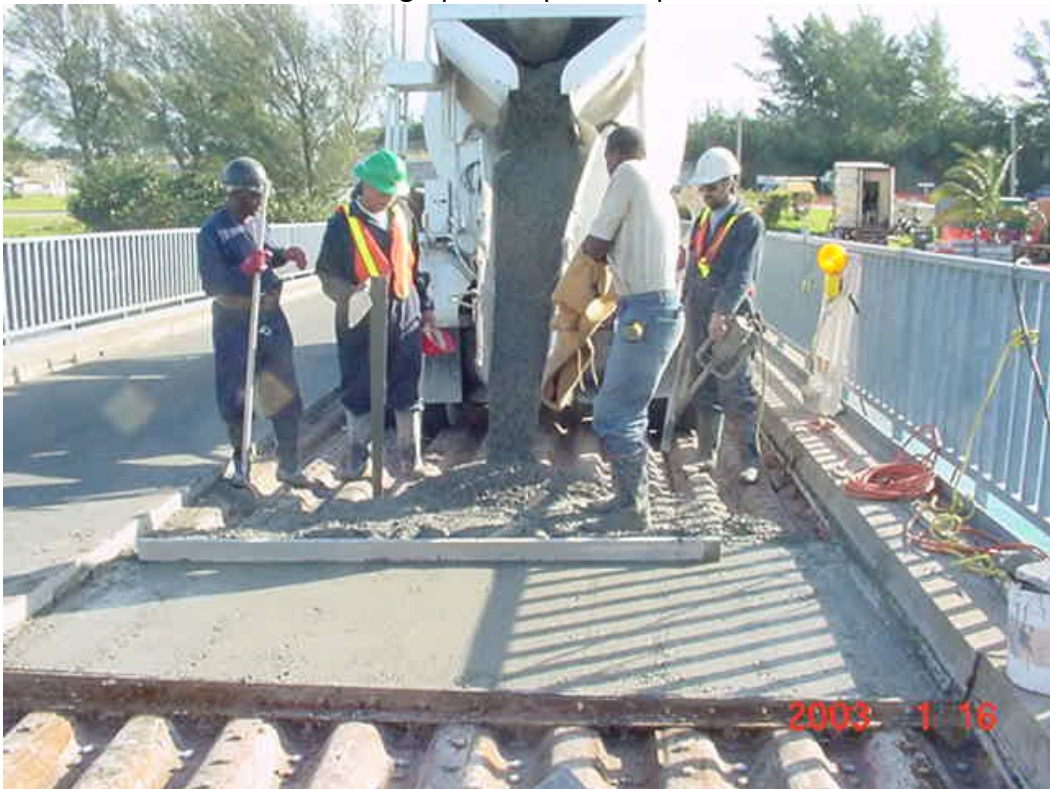
Photograph 8 – Concrete reinstatement

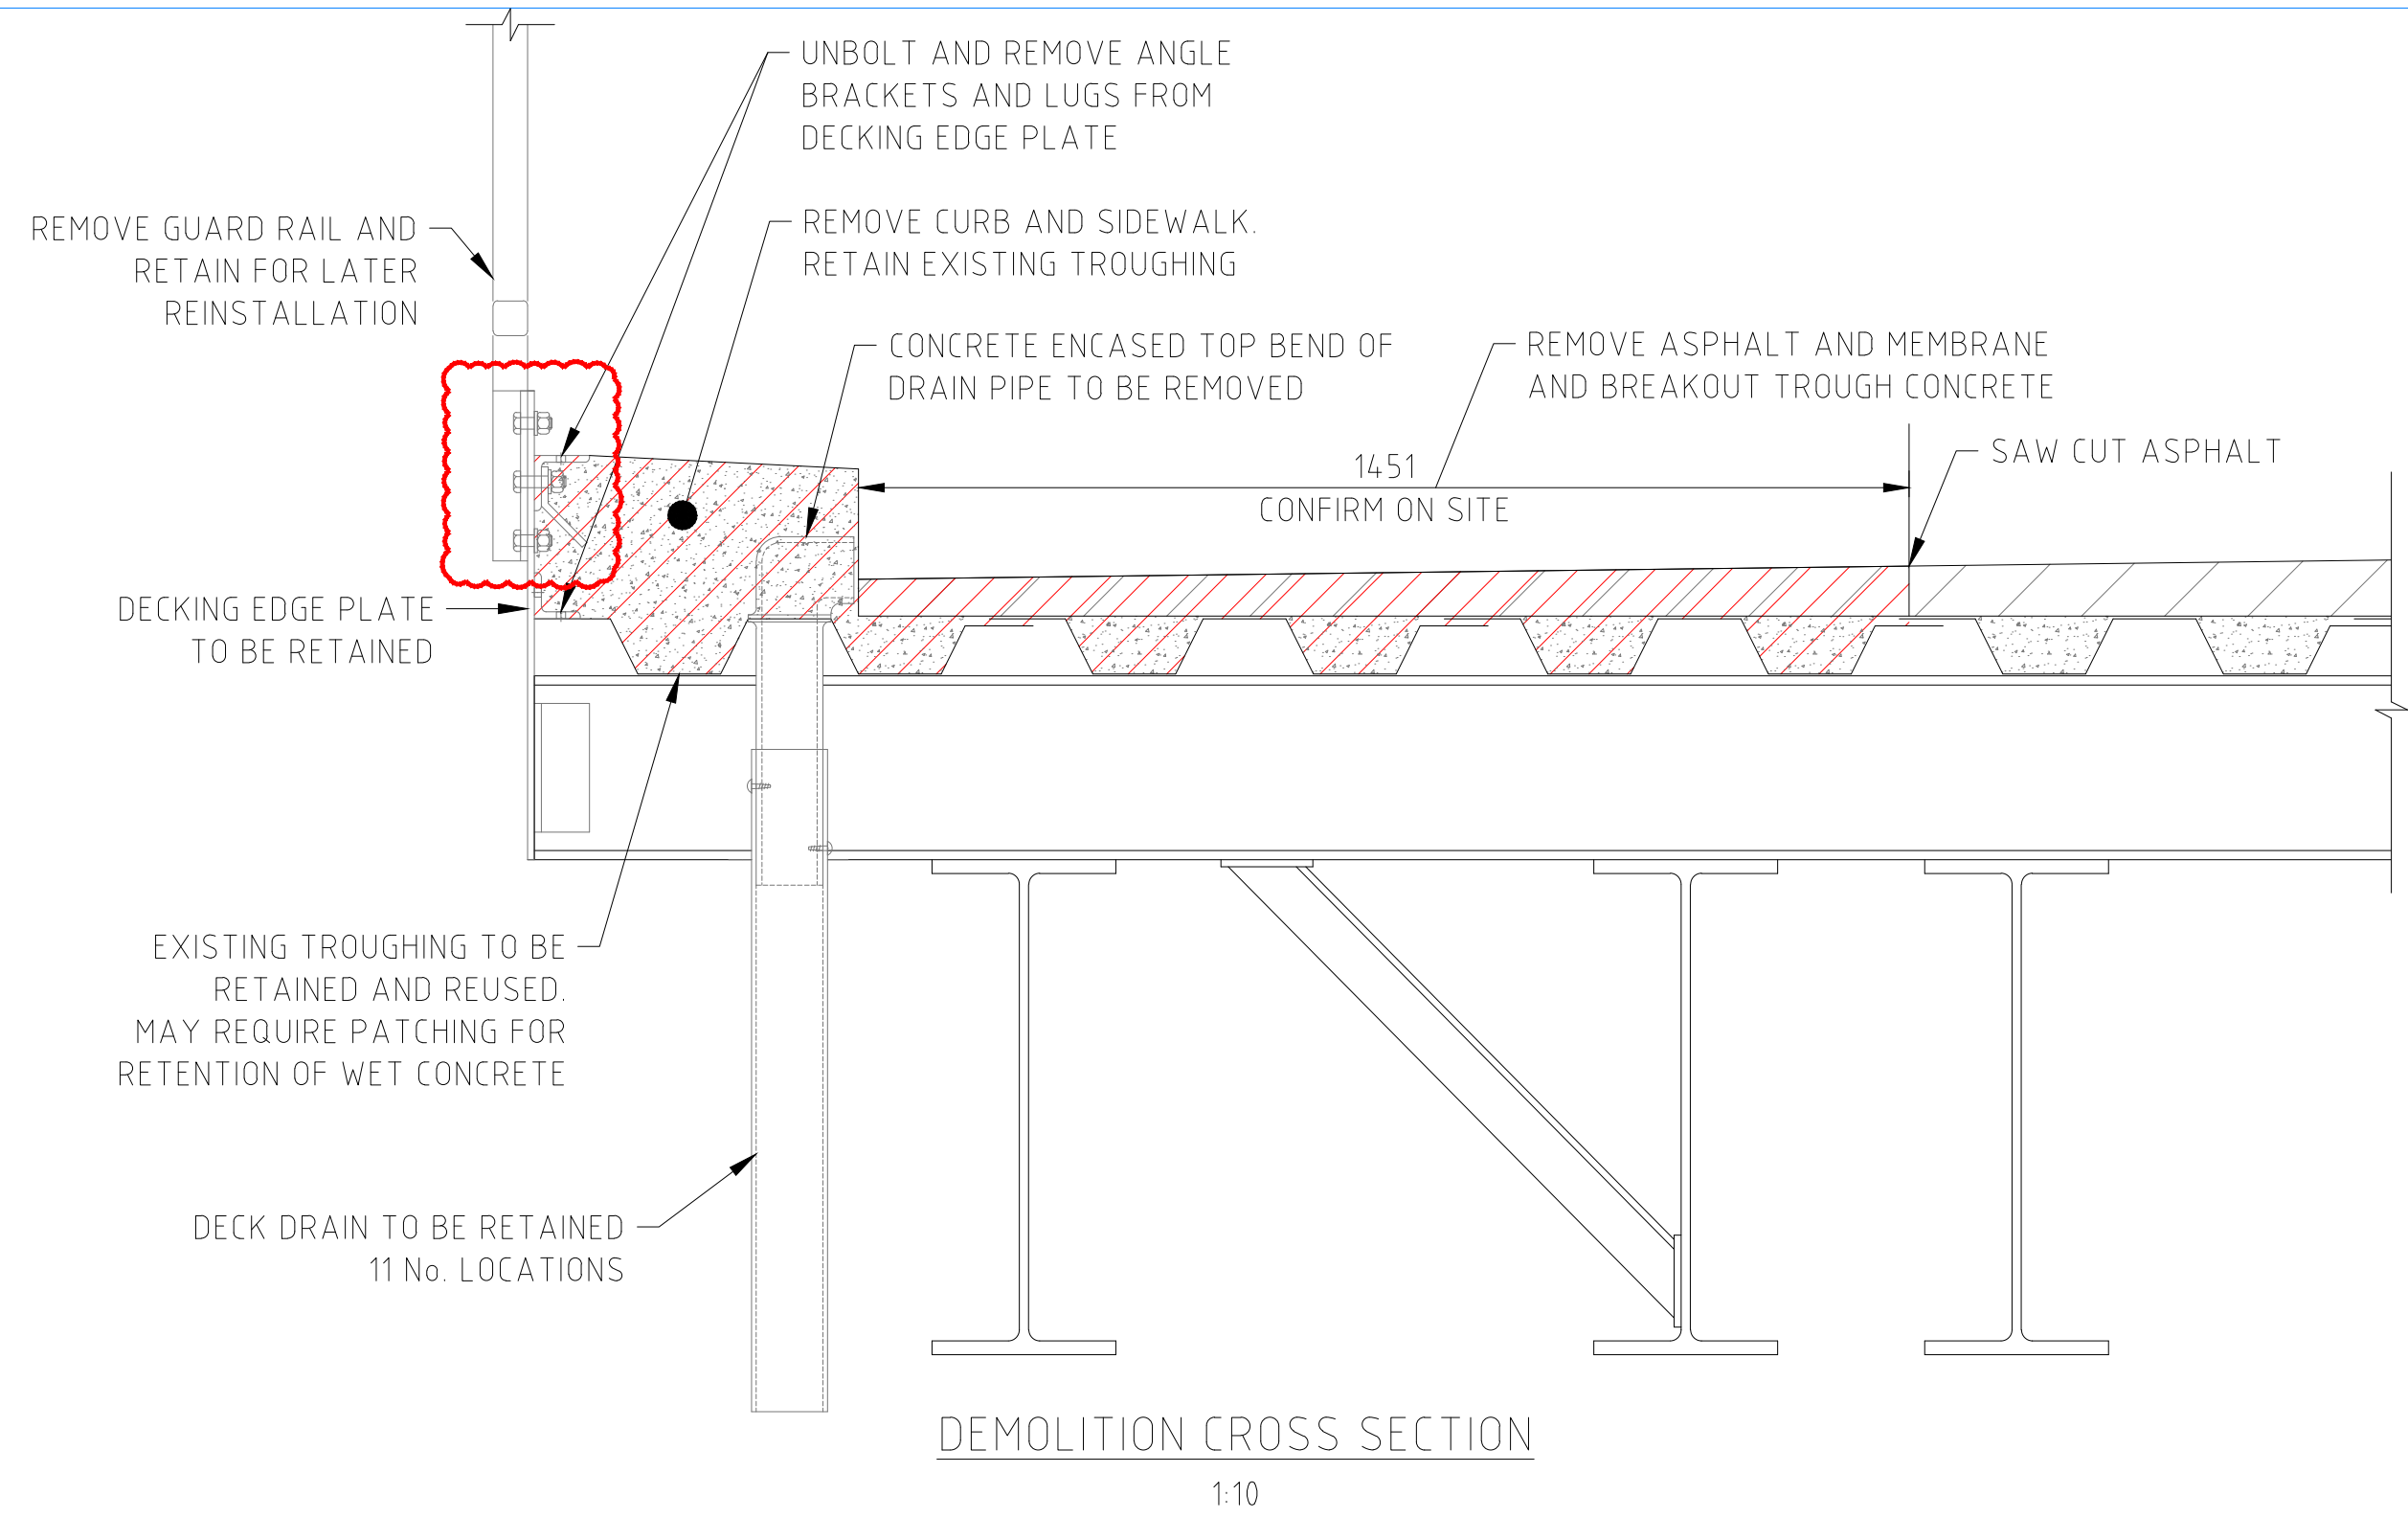
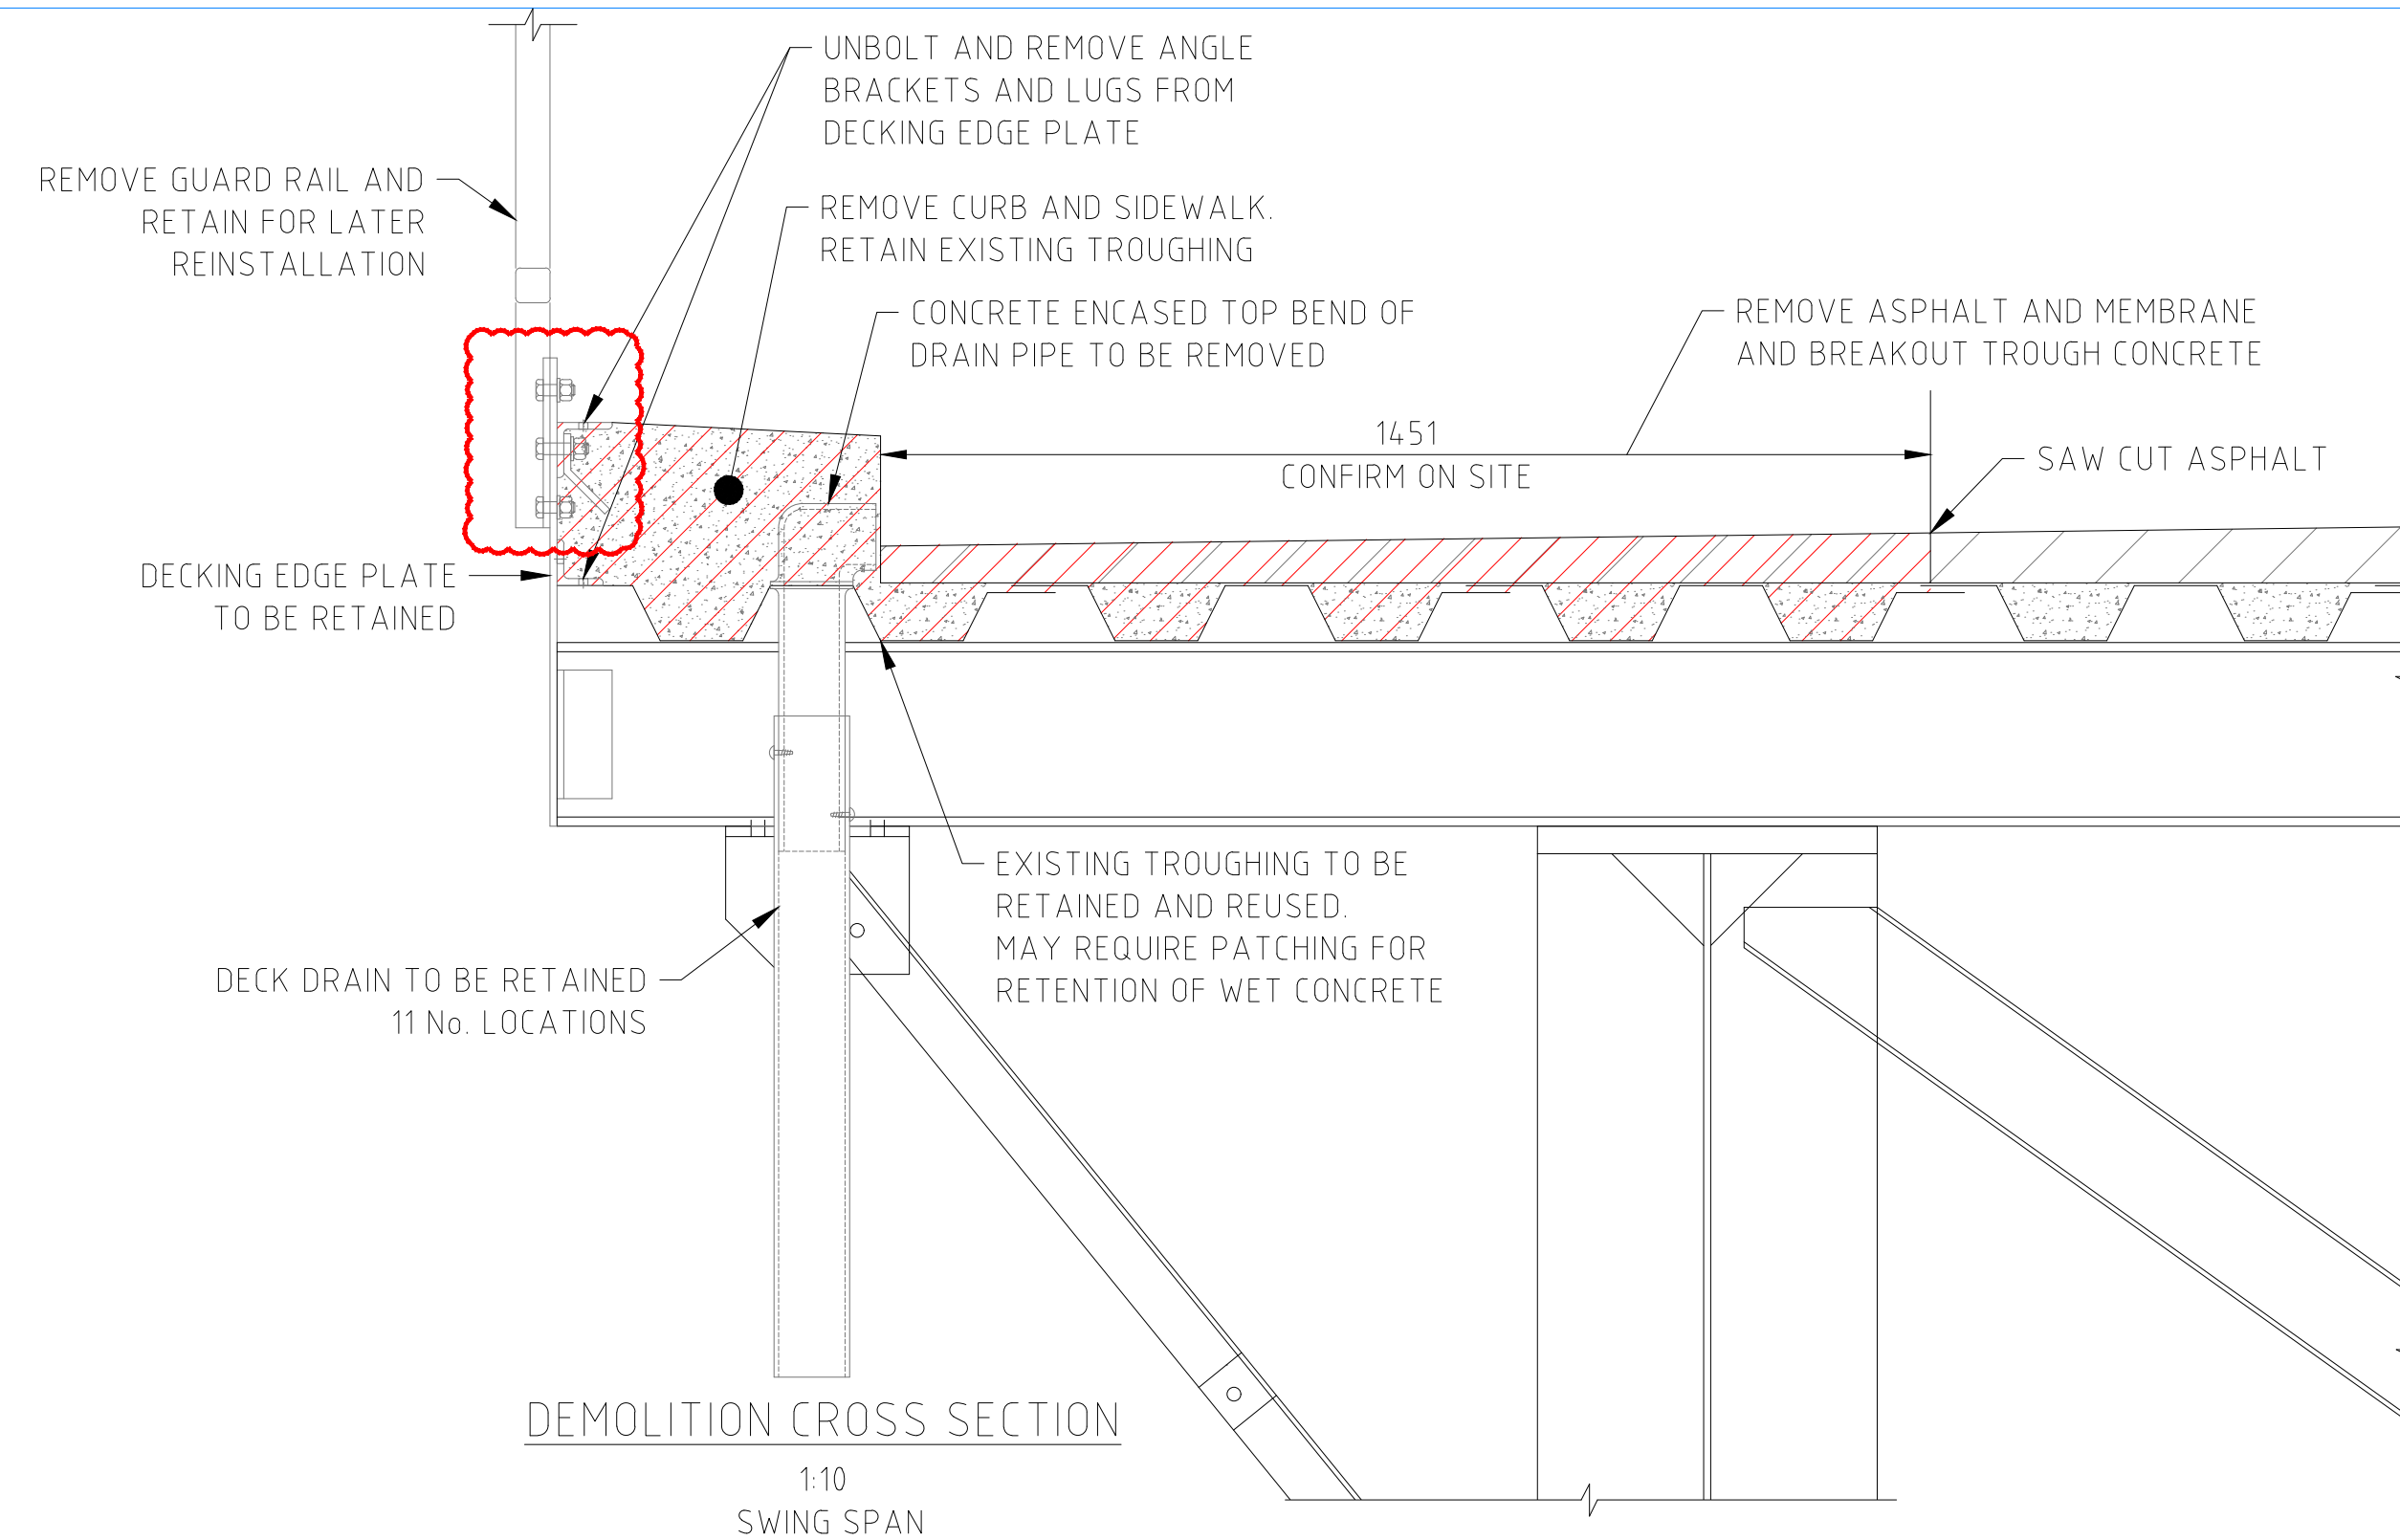
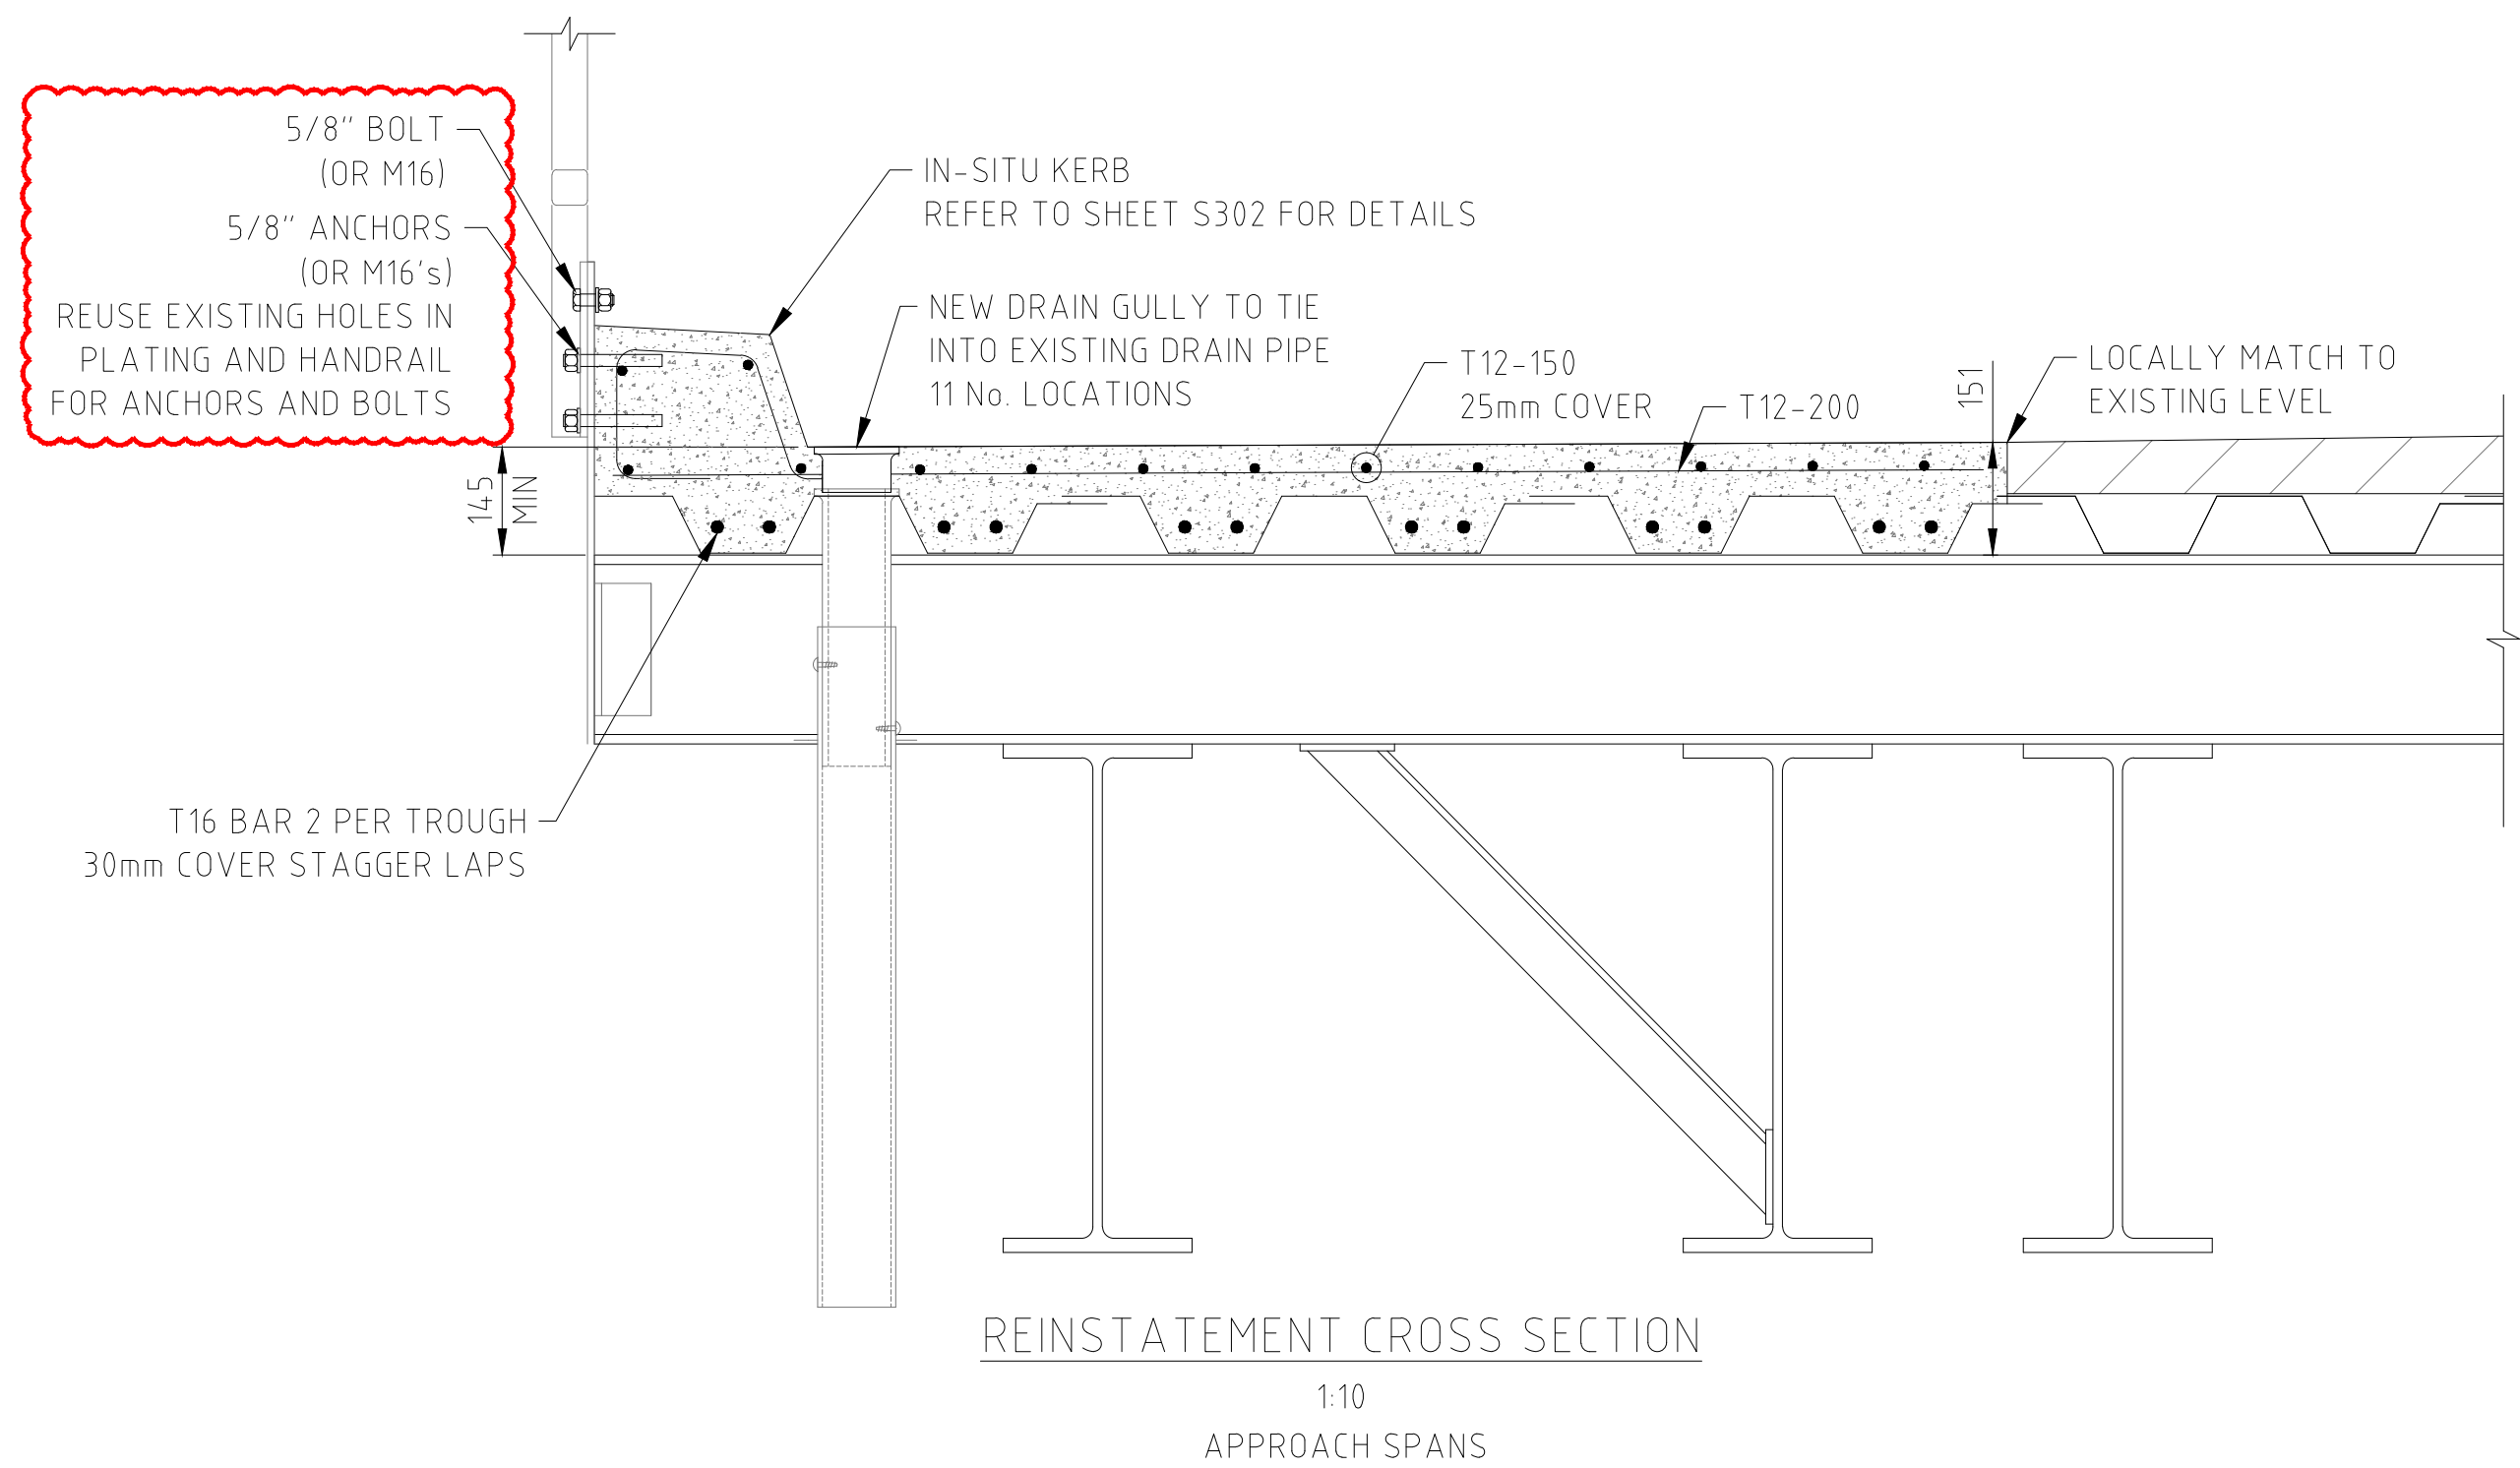
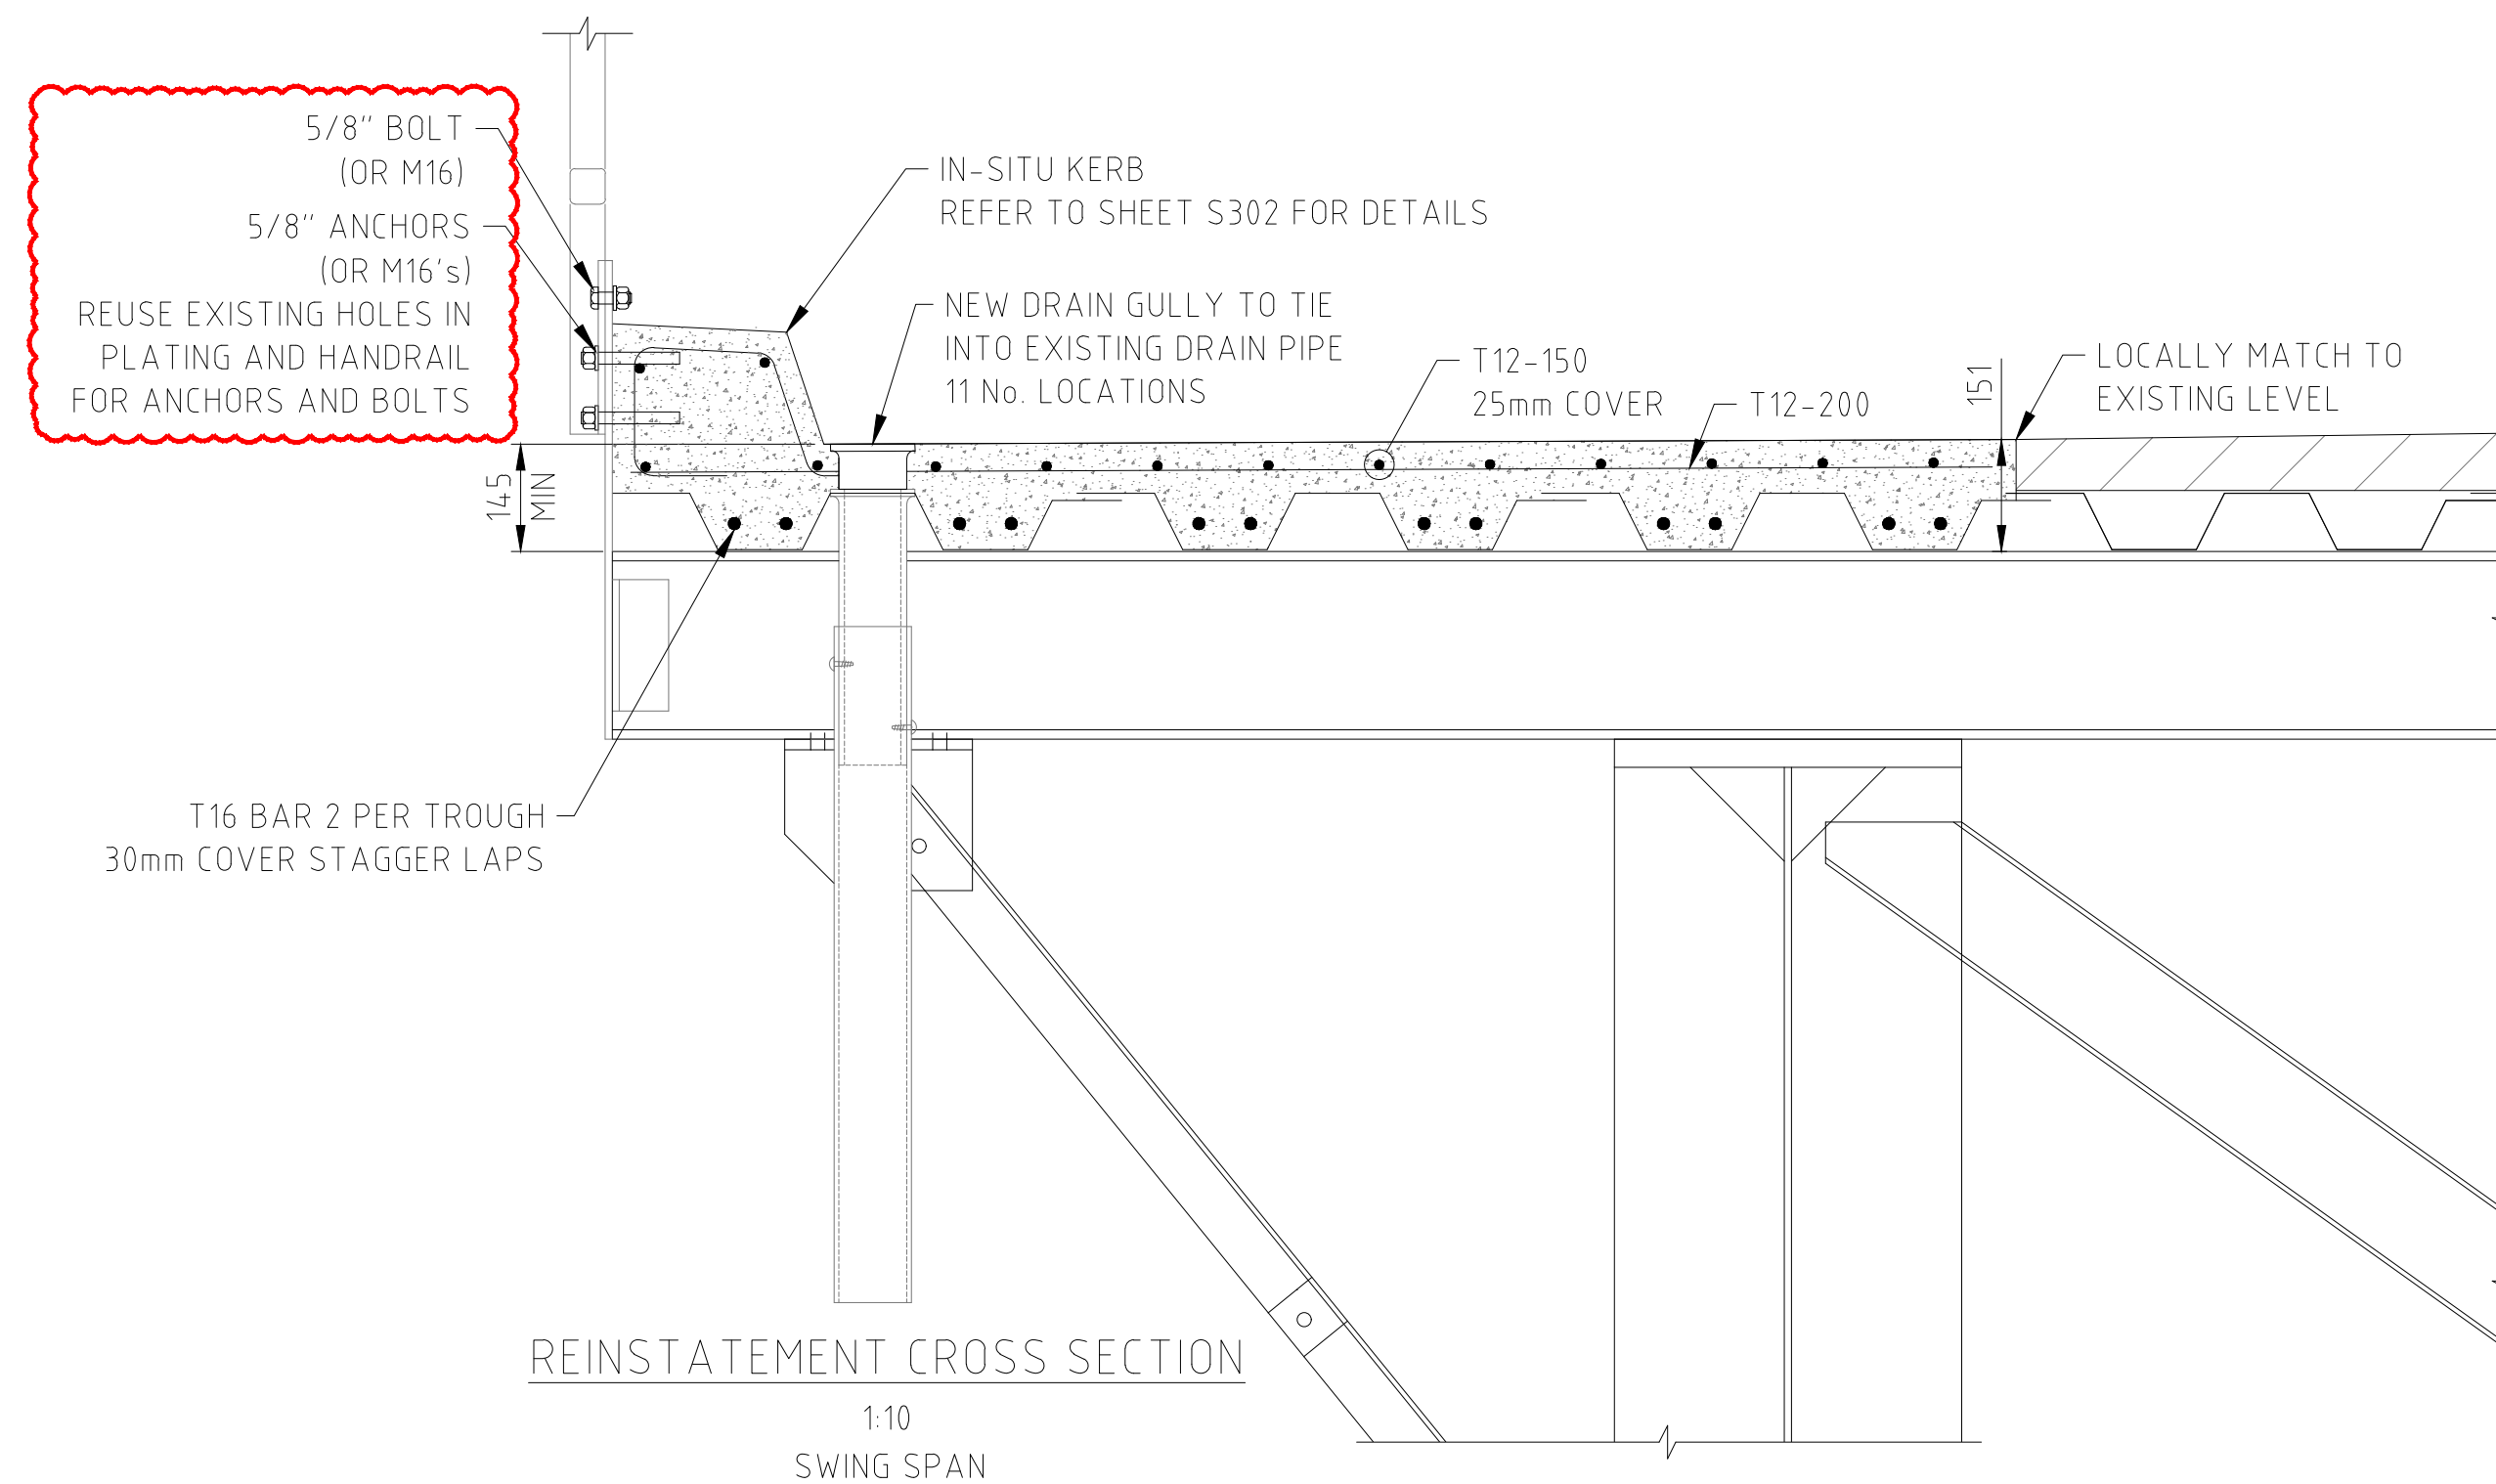
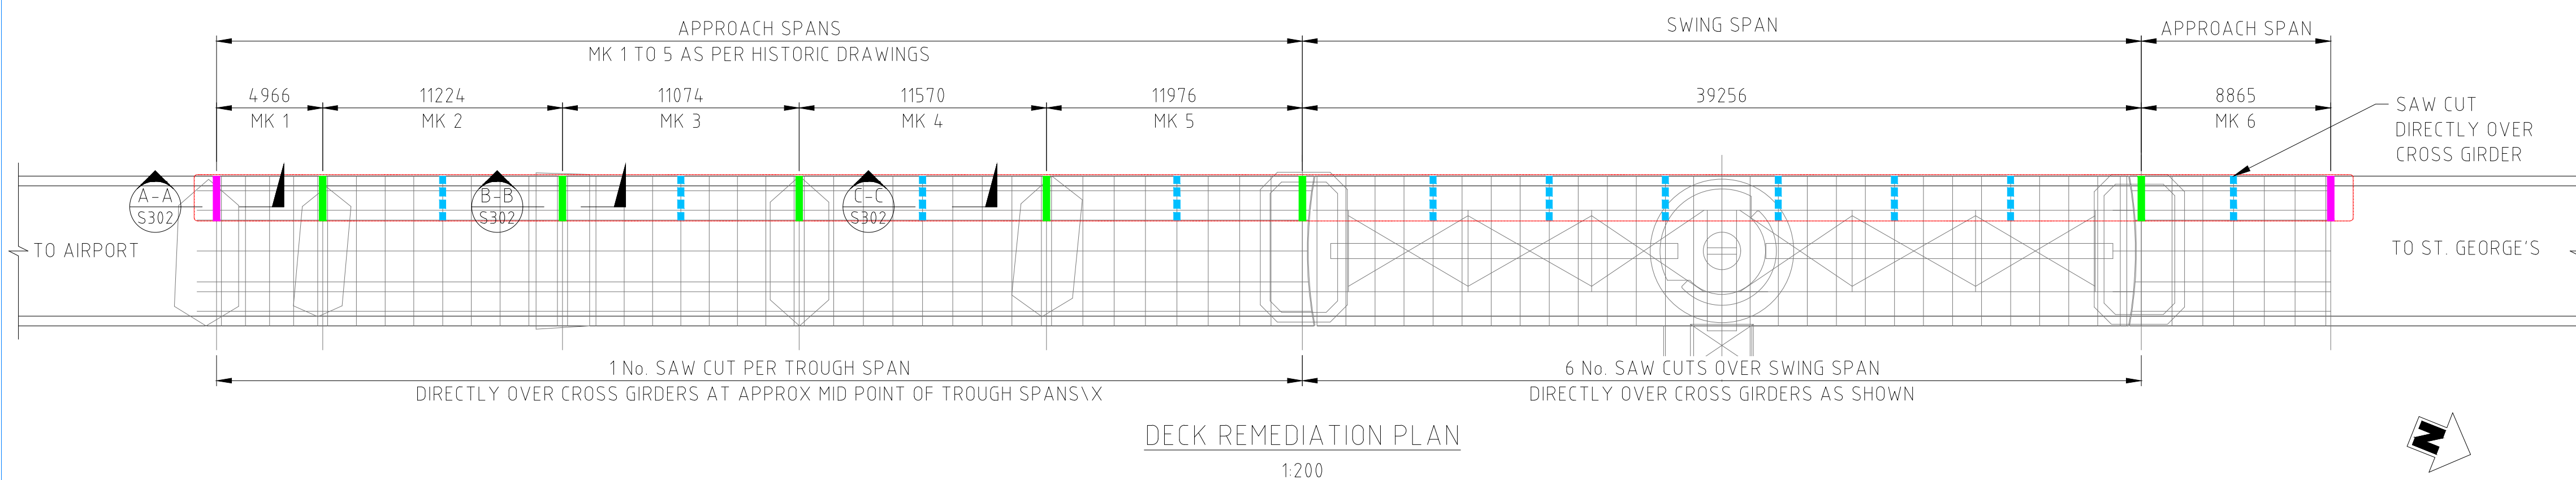
KEY	
—	DECK JOINT (REFER TO SHEET S302 FOR DETAILS)
—	BRIDGE END JOINT (REFER TO SHEET S302 FOR DETAILS)
- - -	SAW CUT (REFER TO SHEET S302 FOR DETAILS)

AMENDMENTS:		
NO:	REVISION	DATE:
0	FOR CONSTRUCTION	01/09/23
1	BOLT AND ANCHOR SIZES CORRECTED	19/09/23
