<b>Site Name:</b>	Prospect Tower
<b>Structure Type:</b>	Guyed Tower
<b>Structure Height:</b>	220'
<b>Make:</b>	Rohn
<b>Model:</b>	80
<b>Tower Owner:</b>	Government of Bermuda
<b>Address:</b>	Fort Hill Road
<b>Parish:</b>	Devonshire
<b>Latitude:</b>	32.299186
<b>Longitude:</b>	-64.765877
<b>Date of Visit:</b>	6/3/2019
<b>Employees on Site:</b>	Angie Shyrigh
	Ben Shyrigh
	Brian Heiney

**Proventus Structural Services, LLC**

To fulfill the inspection requirements set forth in the TIA/EIA222-G, Annex J.1 standard for Maintenance and Condition Assessment of communication structures.

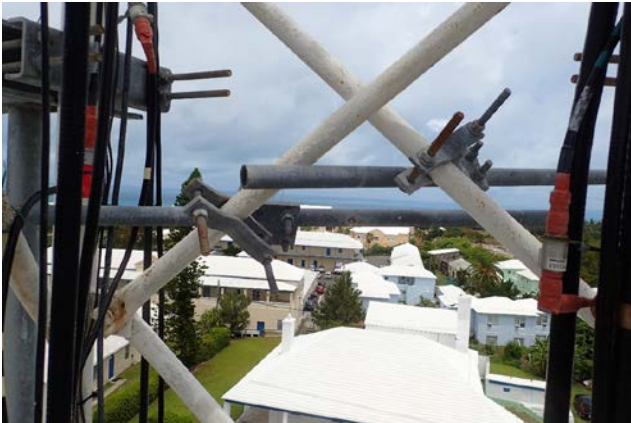
Stiff arm connections  
File 071

Elevation	Location	Description	Recommendation	Priority
78'	AB face	Dead feedlines (loading item #15) were observed to be installed.	It is recommended out of service or otherwise abandoned equipment be completely removed from the structure in order to reduce the resources required to maintain safe connection to the structure as well as to maintain accurate loading records.	To be scheduled
Varies	Varies	The stiff-arm associated with each antenna # 8, #9, #10, #11 is connected to a tower bracing member.	In order to prevent damage to the already structurally compromised bracing members it is recommended the stiff-arm connection be relocated to a tower leg.	To be scheduled

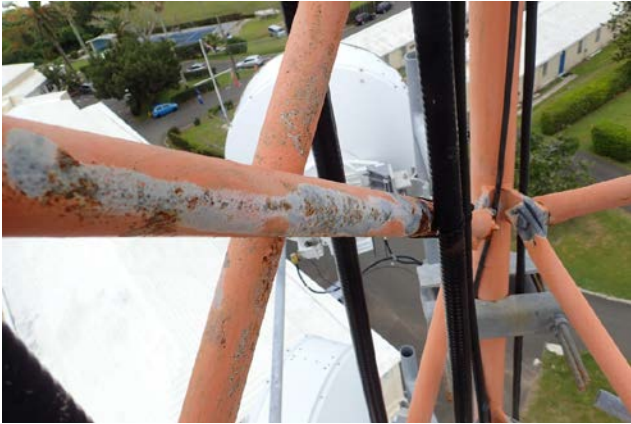
Tower surface condition  
File 081

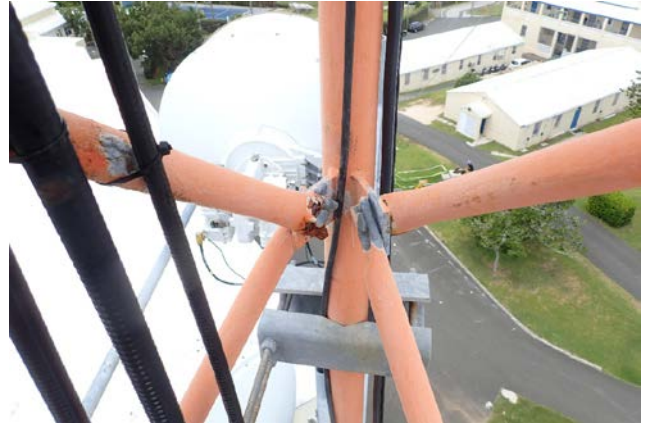
Tower surface condition  
File 082

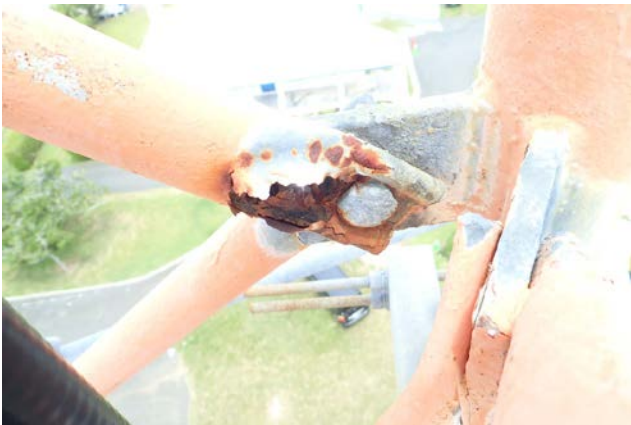
Tower surface condition  
File 083

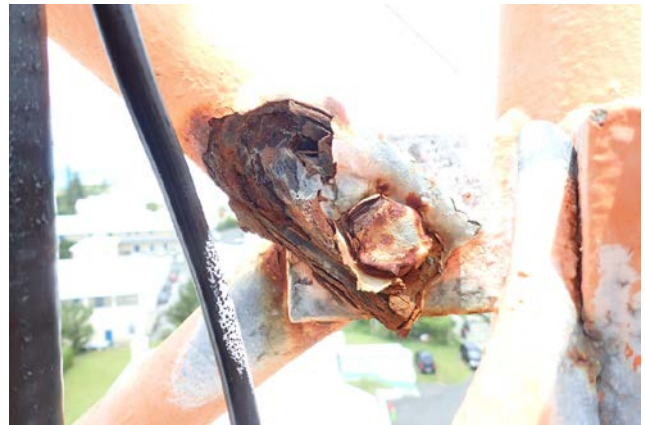
Tower surface condition  
File 084

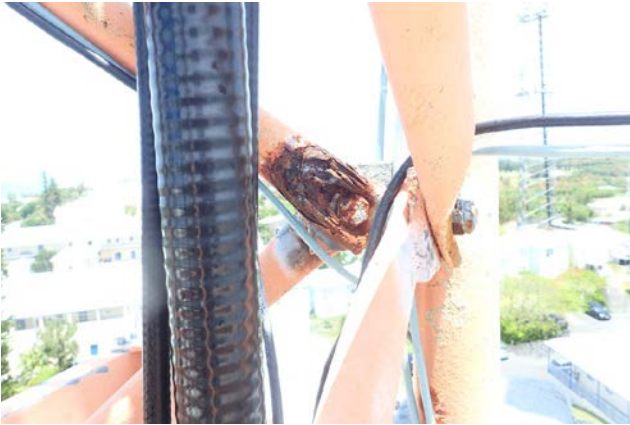
Tower surface condition  
File 095

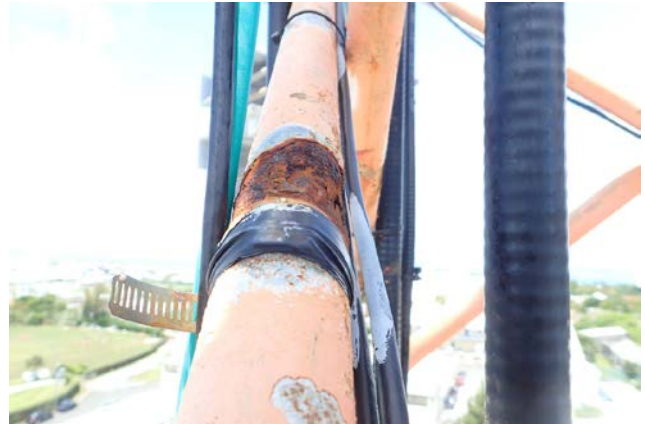
Tower surface condition  
File 096

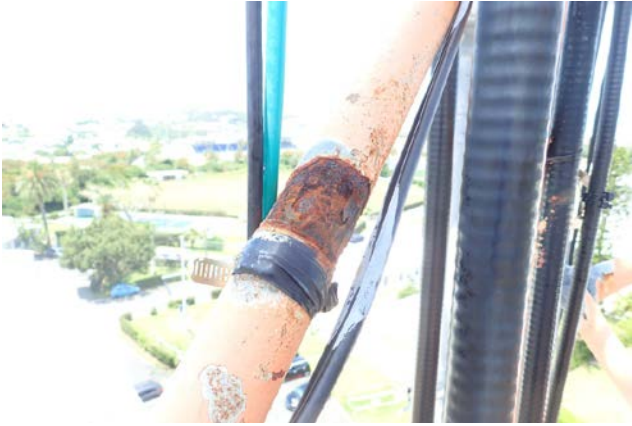
Tower surface condition  
File 097

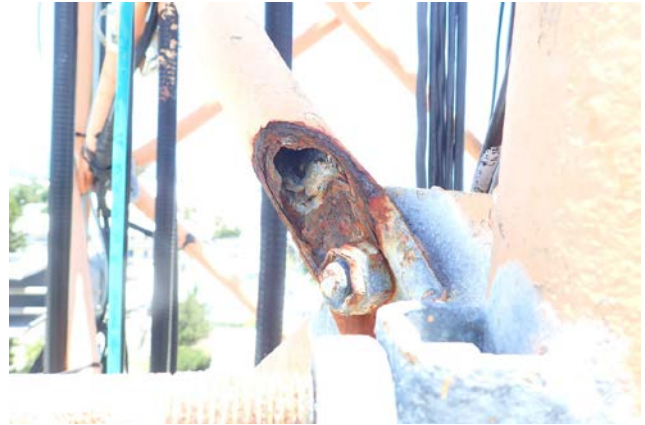
Tower surface condition  
File 100

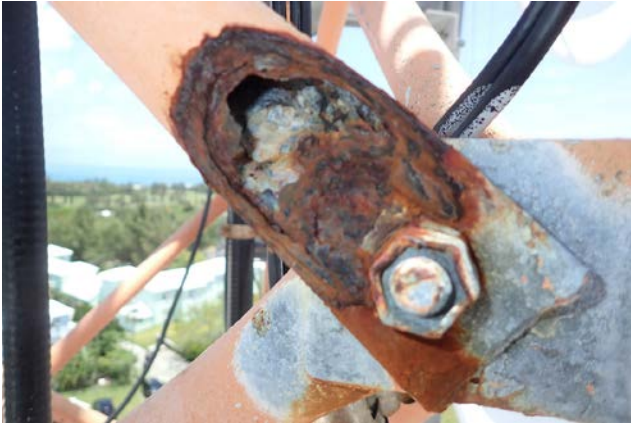
Tower surface condition  
File 101

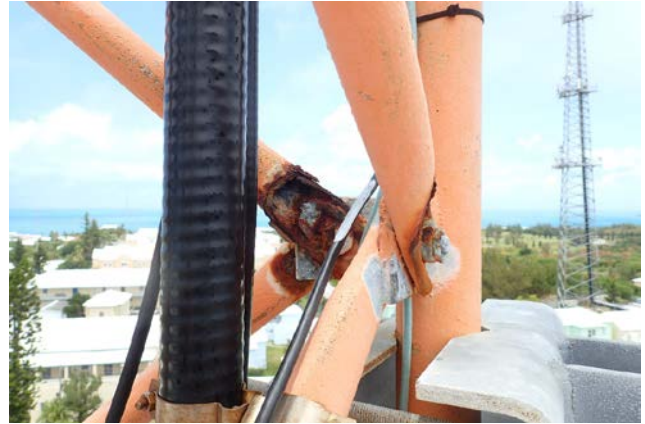
Tower surface condition  
File 102

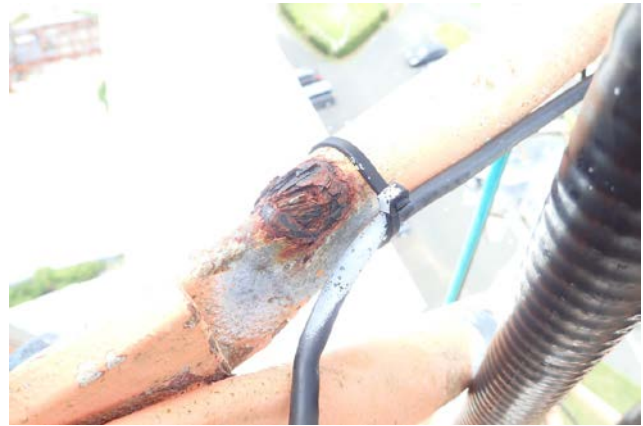
Tower surface condition  
File 106

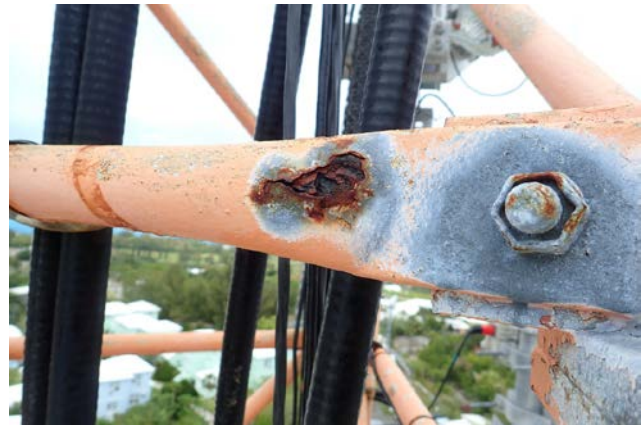
Tower surface condition  
File 108

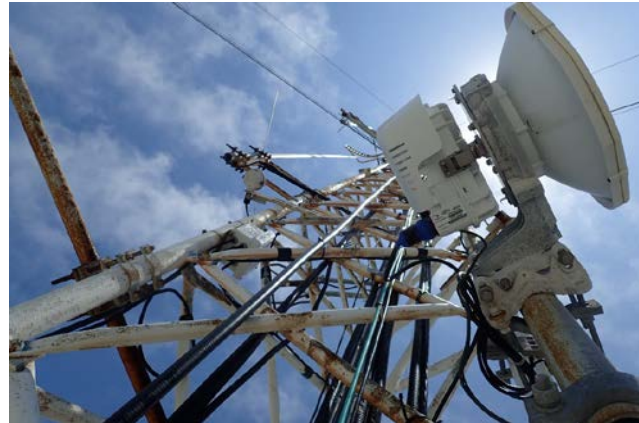
Tower surface condition  
File 112

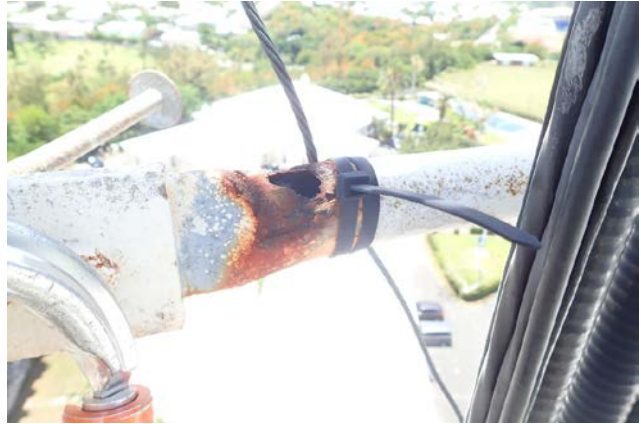
Tower surface condition  
File 114

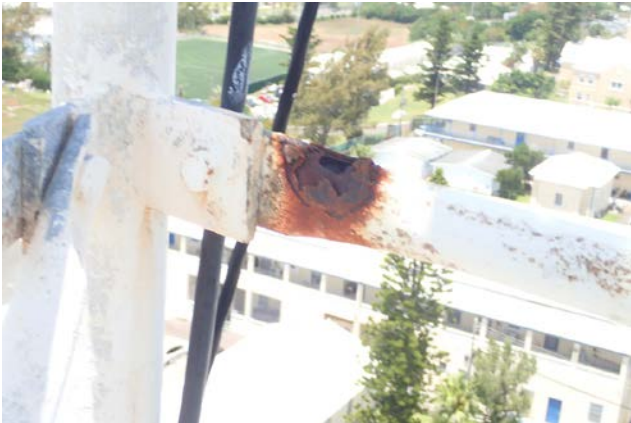
Tower surface condition  
File 115

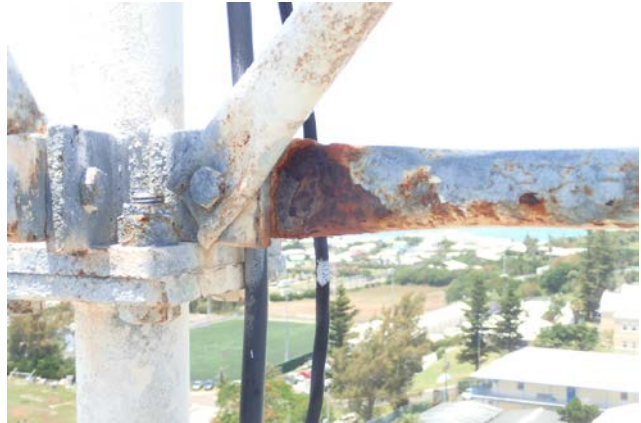
Tower surface condition  
File 116

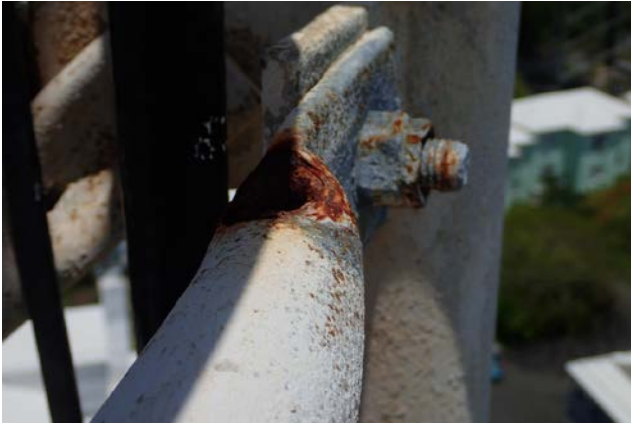
Tower surface condition  
File 117

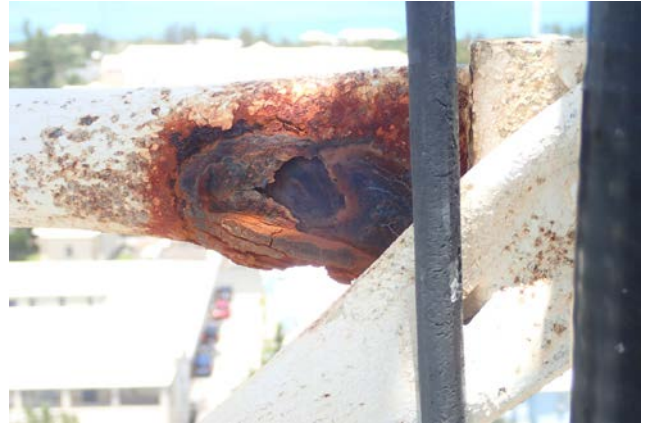
Tower surface condition  
File 118

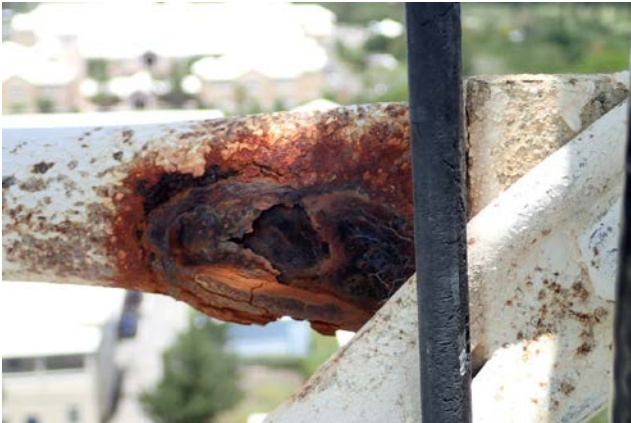
Tower surface condition  
File 119

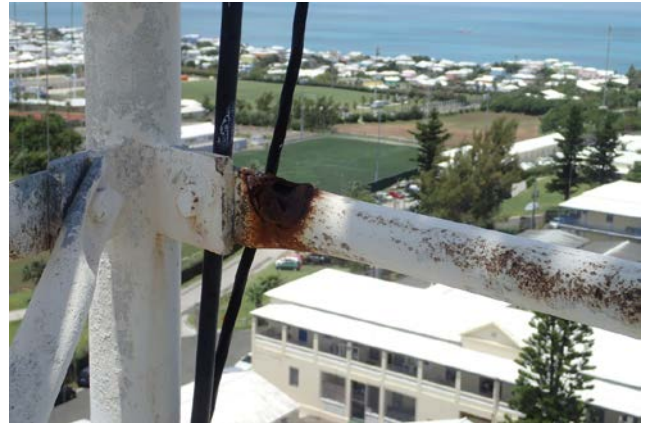
Tower surface condition  
File 120

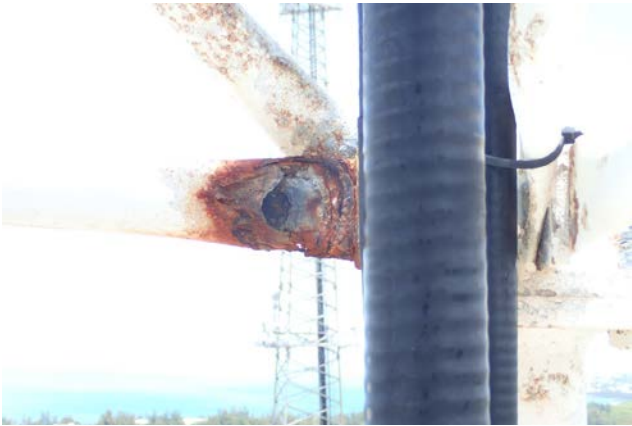
Tower surface condition  
File 121

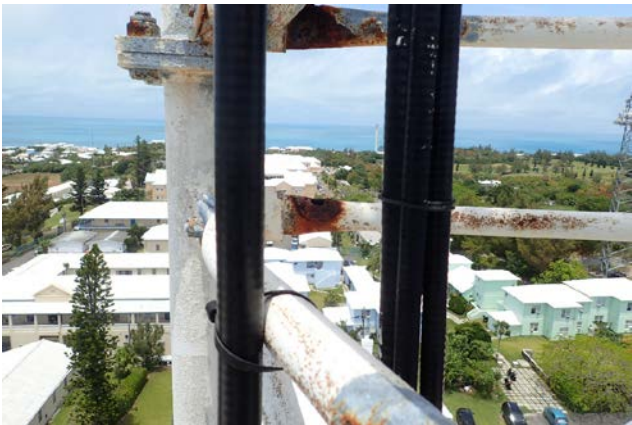
Tower surface condition  
File 123

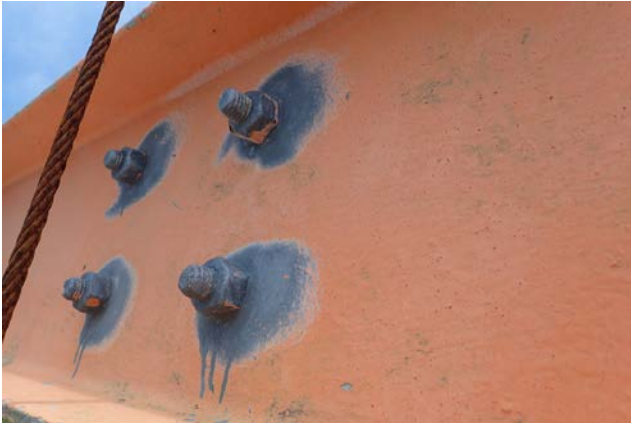
Torque arm hardware  
File 125

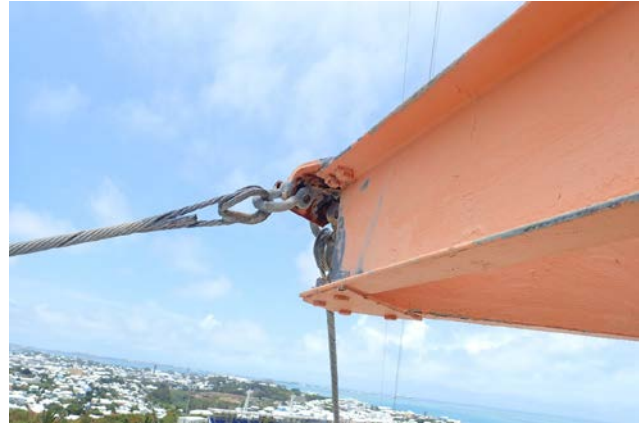
Torque arm hardware  
File 126

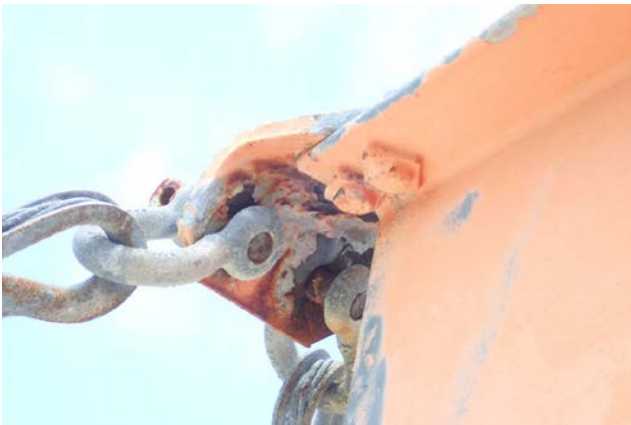
Guy attachment  
File 127

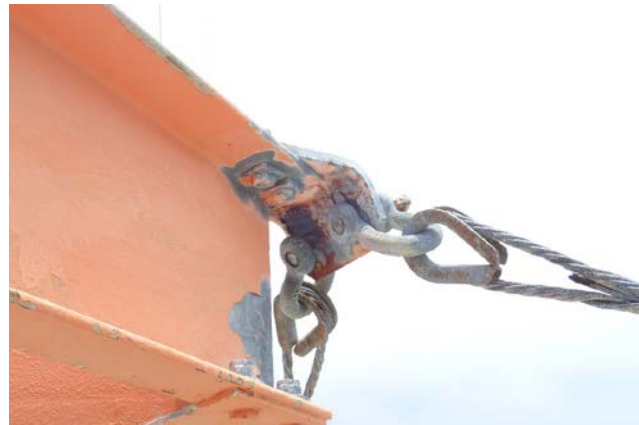
Guy attachment  
File 128
